Inspection Report

24 Canterbury Tales
Chaucer, VT 02222

4/29/1387
2:30 PM

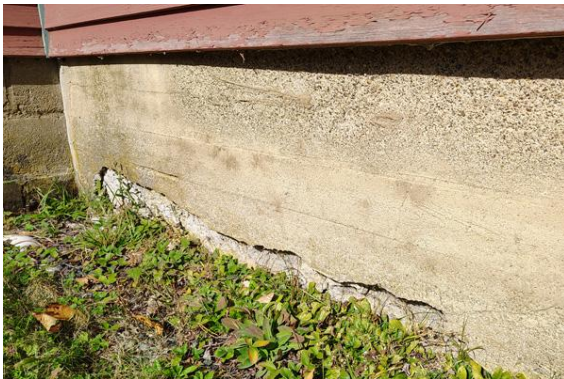
Rec ID 1039

Foundation : Spalling concrete

Spalling is a condition of concrete where the concrete begins to flake off. This is commonly caused by freeze/thaw cycles. Spalling was observed on both sides of the foundation around the front porch. This is likely caused by the lack of water management from the roof. This should be evaluated by a structural engineer specializing in foundation systems.

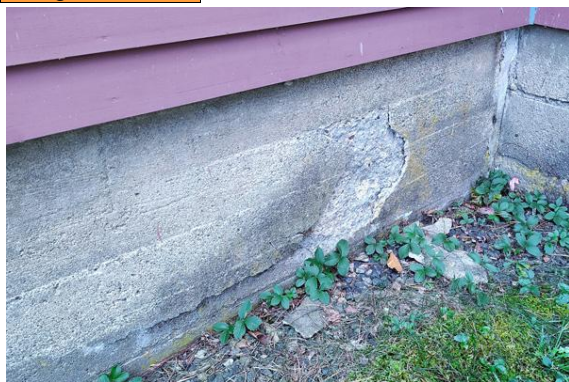
Rec ID 1038

Foundation : Spalling concrete

Spalling was observed on both sides of the foundation around the front porch. Spalling is typically the result of freeze thaw cycles. This should be evaluated by a structural engineer specializing in foundation systems.

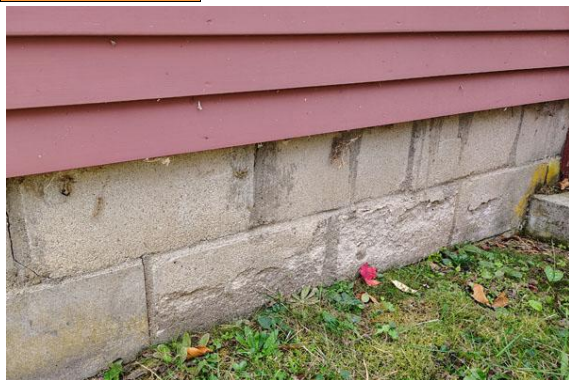
Rec ID 1188

Foundation spalling

More spalling concrete found. This was observed on the right (North) side.

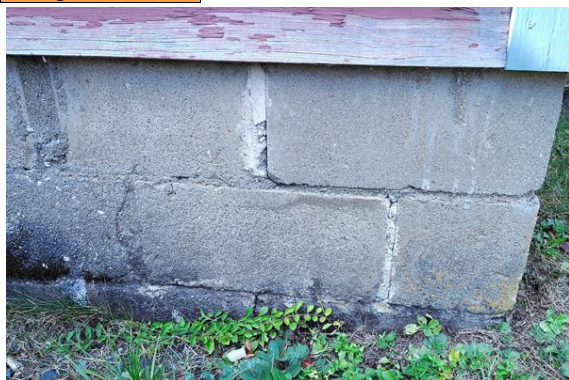
Rec ID 1041

Foundation: repointing

Foundation has a few areas that need repointing. Flaking mortar was observed on the right side below the service entrances.

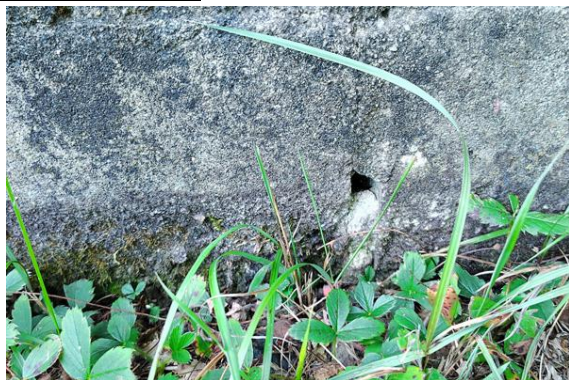
Rec ID 1040

Foundation: repointing needed

Foundation has a few areas that need repointing. This missing mortar was observed on the main house - front - left side. This void goes all the way through to the basement.

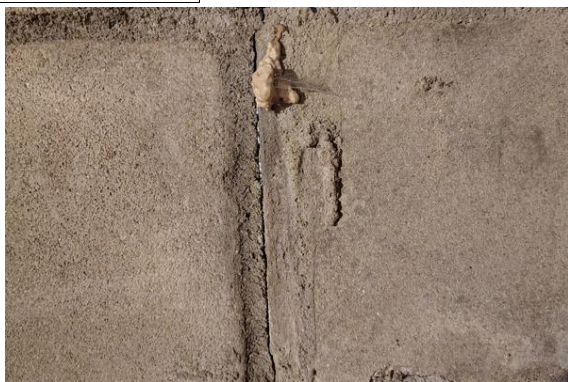
Rec ID 2087

As mentioned on the exterior foundation narrative, repointing is needed in a few areas in the interior portion as well.

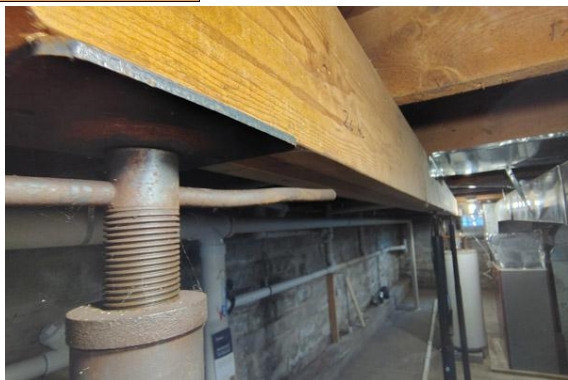
Rec ID 2085

Improper beam support

This beam structure was constructed using adjustable posts. Adjustable posts are considered temporary support. In addition there does not appear that proper footings are not installed under these posts.

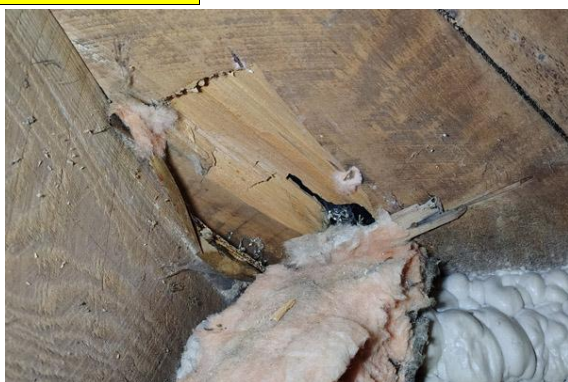
Rec ID 2044

First floor subfloor cracked and concealed.

Observed this subfloor with significant crack. I believe this may be under the kitchen cabinets.

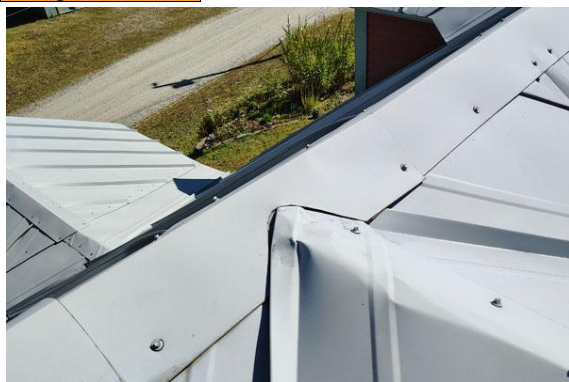
Rec ID 1205

Improper Installation

Roof was installed not using recommended installation practices. In this case it appears that the valleys were (top of the valley seen here against the ridge) installed using the standing seam panels rather than a valley panel. I've seen this type of roof installed this way on a few other homes but it should be noted that this installation is improper.

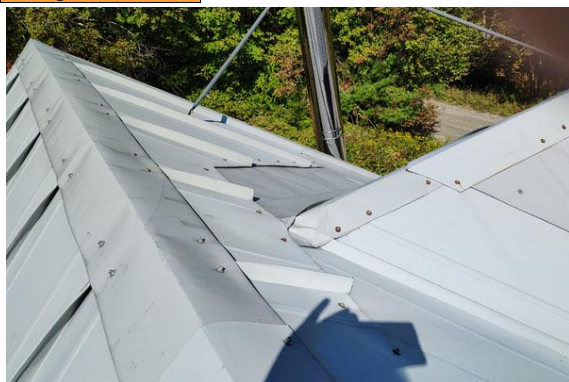
Rec ID 1204

Improper installation

More pictures of improper material selection and installation.

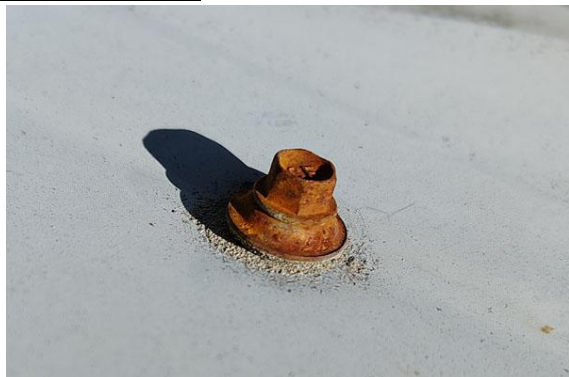
Rec ID 1203

I observed many of the fasteners on the roof appear to be at end-of-life. These fasteners are fitted with a neoprene gasket to prevent water intrusion through the screw penetration. The lifespan of these screws are typically between 10 and 20 years depending on environmental exposure. These should be replaced before water can find its way past the gasket material.

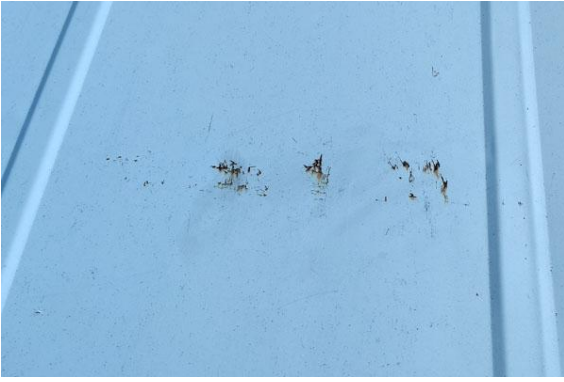
Rec ID 1206

Roof scratch resulting in rust

There are a few spots on the roof that appear to have been scratched. Scratching the roof can lead to accelerated deterioration.

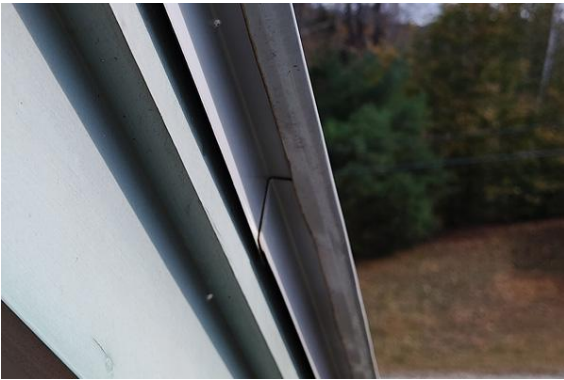
Rec ID 1221

South side. Drip edge should be installed so that the upper section overlaps the lower section by at least 2". This was installed so that the lower section overlaps the upper section and overlapped by only ~1/4". This requirement is so that any water that may be clinging and running down the drip edge does not find its way to the roof decking. This same defect was observed on all rake edges of the main roof.

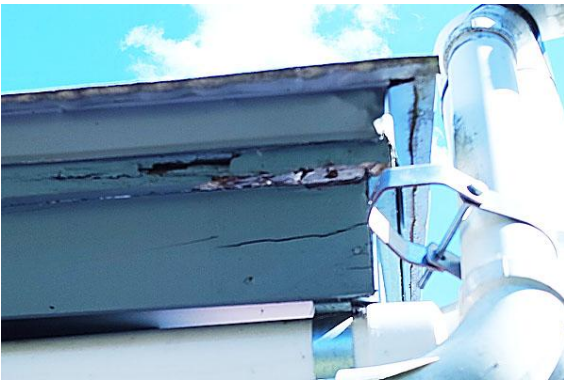
Rec ID 1194

The fascia by the output of the radon system output is rotted. I discovered a missing roof fastener directly above this where water could enter the screw hole. This may have contributed to the defect.

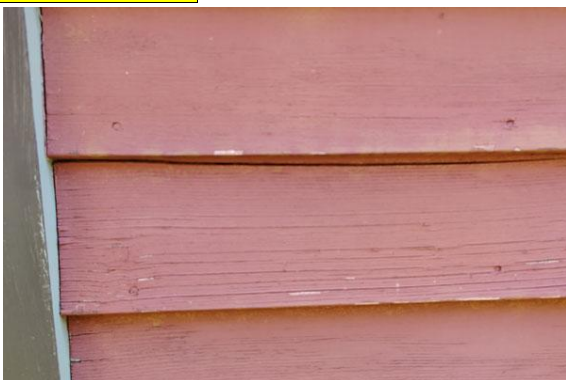
Rec ID 1181

Trim rot

More trim issues. This example is currently rotting and needs replacement.

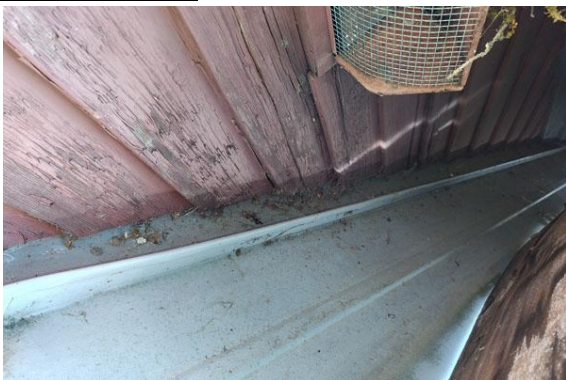
Rec ID 1191

Siding: siding shows signs of advanced age due to weathering

More examples of clapboard siding that should be replaced. The board is checked and would allow moisture to penetrate behind the siding.

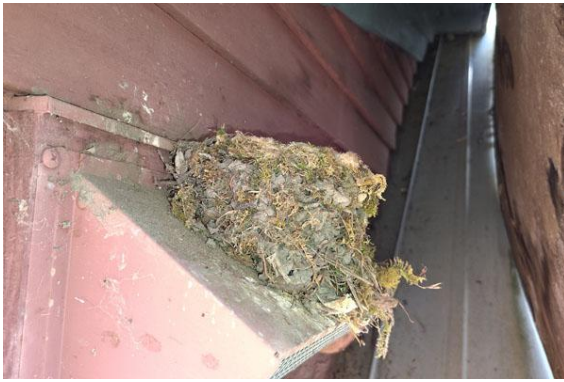
Rec ID 1192

Area behind plywood shows excessive weathering

More siding that appears to be at end of life due to lack of maintenance.

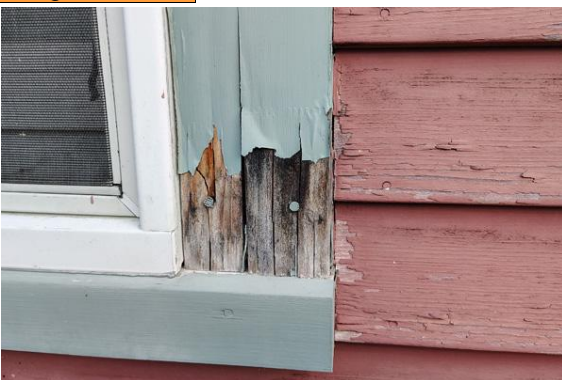
Rec ID 1225

Trim board weathered

Image from the right side of the house

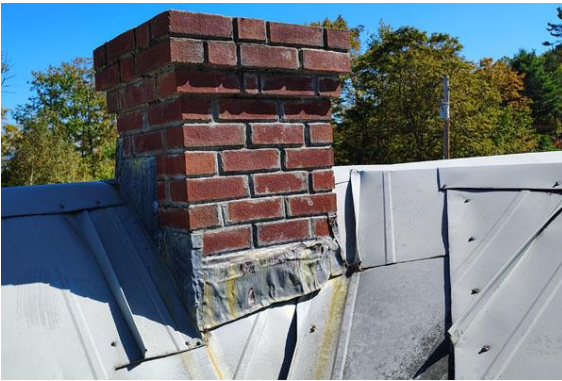
Rec ID 1202

Flashing and crown are deteriorating

There were a few areas on the chimney flashing that are cracked and allowing water to enter. This should either be sealed using silicone caulk (temporary) or the flashing should be redone (permanent). This should be evaluated/corrected by a chimney expert.

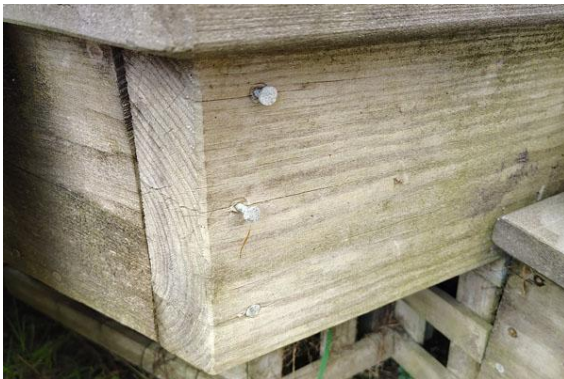
Rec ID 1182

Deck framing is becoming loose

The construction of the deck is becoming loose with age. These nails should be replaced with construction screws to assure a tight fit.

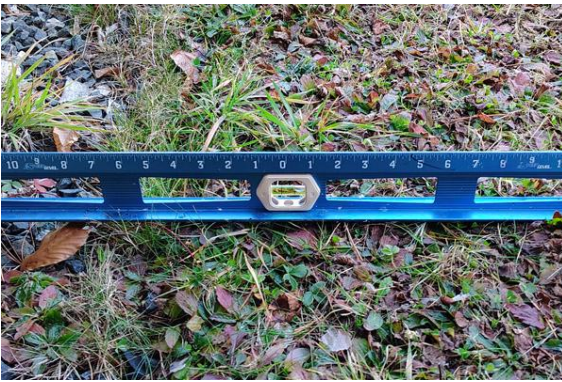
Rec ID 2134

Terrain sloped toward foundation

Several areas around the house are sloped toward the foundation. This should be corrected as water infiltration and hydrostatic pressure is a concern if not addressed. Test

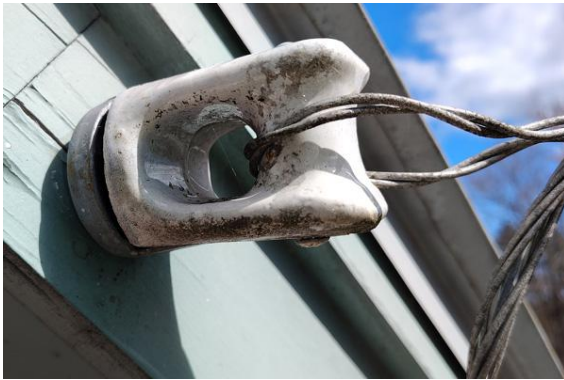
Rec ID 1219

The service drop hanger may be pulling slightly away from building. This is a potential hazard if this fails as stress would be put on the service point (connection between the Service Drop and Service Entrance). I recommend an electrician evaluate and replace/resecure with a more appropriate hanger.

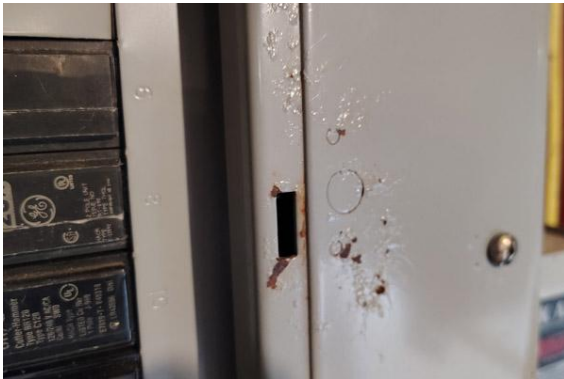
Rec ID 2055

The dead front is the front of the electric panel. It is removable (by screws) to gain access to the circuit breakers and wiring. I observed some corrosion in a couple areas of the panel. This was only on the cover, I did not see any corrosion in the panel itself.

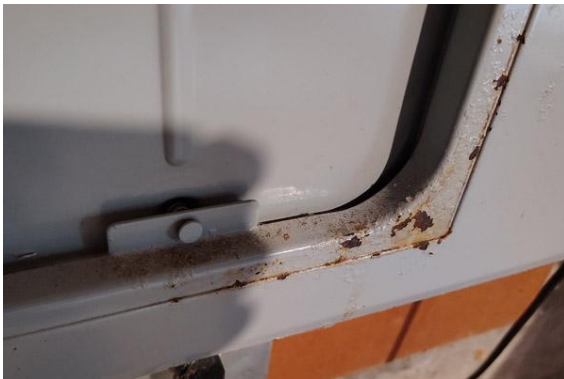
Rec ID 2056

More corrosion on the dead front. I observed The inside of the panel shows no corrosion.

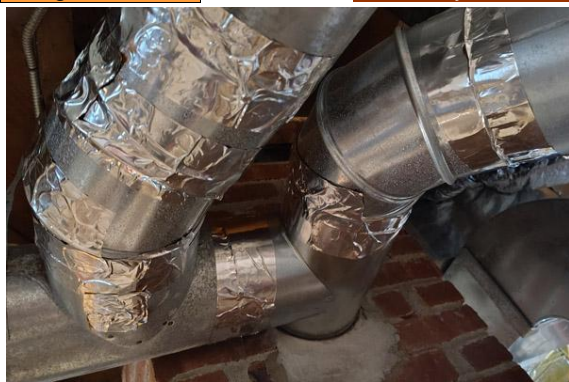
Rec ID 2072

The water heater enters the vent using a 6" Tee fitting. This could cause combustion air spillage into the basement from the backdraft damper until proper draft is achieved up the chimney. This should be evaluated and corrected by a HVAC technician.

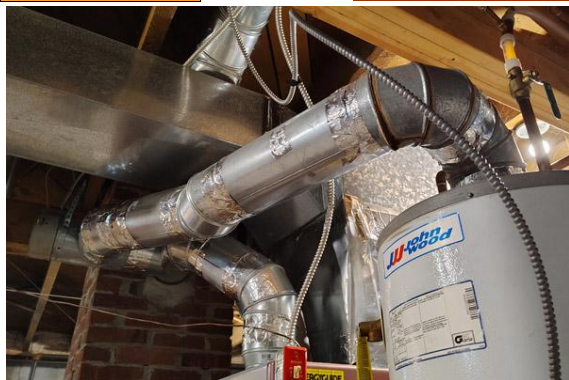
Rec ID 2071

The water heater is vented into a Tee fitting prior to entering the chimney. This could cause combustion air to backdraft out of the backdraft damper into the basement before proper draft is achieved up the chimney. This is a safety concern that should be addressed immediately. Recommendation: contact heating or plumbing contractor for repair.

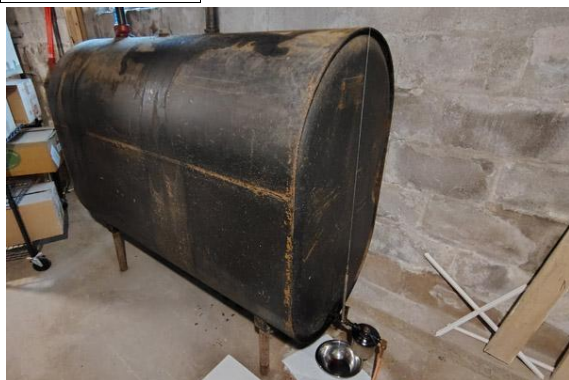
Rec ID 2073

The heating equipment and water heater is fueled with fuel oil. This is an older tank as is evidenced from the rust. The tank itself is not leaking however the fittings before the fuel filter exhibits a slow drip.
