hepburnhomeinspections.com

Inspection Report

24 Canterbury Tales
Chaucer, VT 02222

Inspection Type: Pre-Purchase

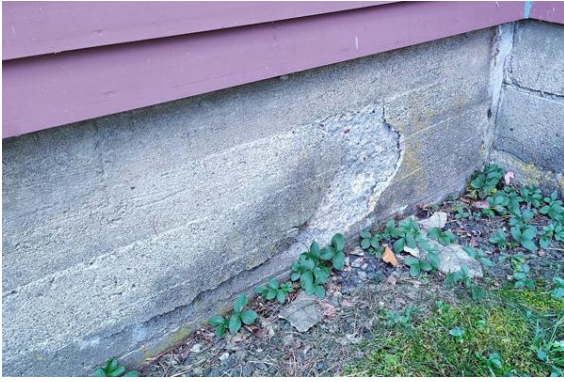
Rec ID 1038

2.1 (3) Structure : Main House : Exterior : Foundation

Marginal Defect

Foundation : Spalling concrete

Spalling was observed on both sides of the foundation around the front porch. Spalling is typically the result of freeze thaw cycles. This should be evaluated by a structural engineer specializing in foundation systems.

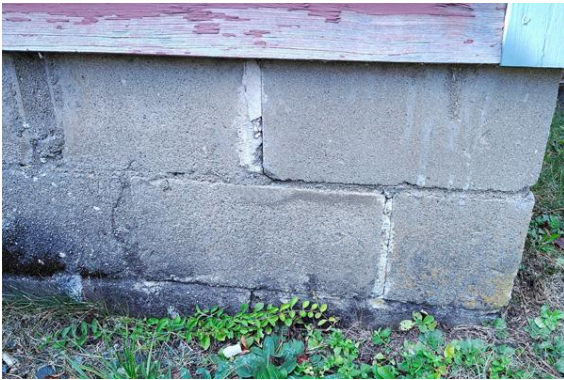
Rec ID 1041

2.1 (5) Structure : Main House : Exterior : Foundation

Marginal Defect

Foundation: repointing

Foundation has a few areas that need repointing. Flaking mortar was observed on the right side below the service entrances.

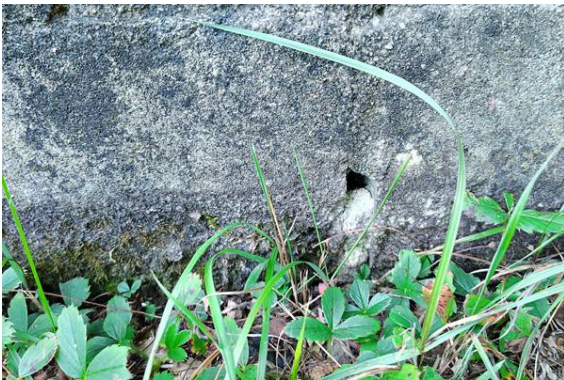
Rec ID 1040

2.1 (6) Structure : Main House : Exterior : Foundation

Marginal Defect

Foundation: repointing needed

Foundation has a few areas that need repointing. This missing mortar was observed on the main house - front - left side. This void goes all the way through to the basement.

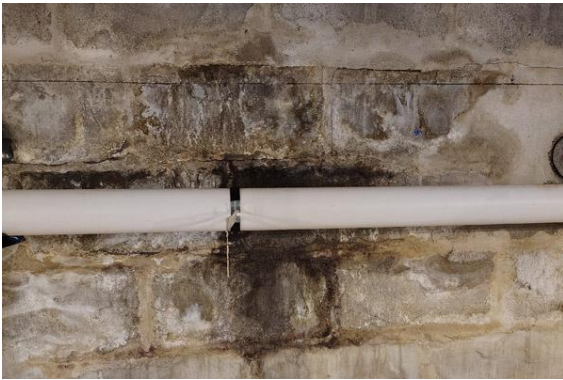
Rec ID 2067

3.1 (1) Structure : Main House : Interior : Foundation

Material Defect

Water penetration observed

The foundation at the back of the house shows moisture penetration. This is the same area where the crack appears to be. Horizontal cracks are evidence of hydrostatic pressure on the foundation.

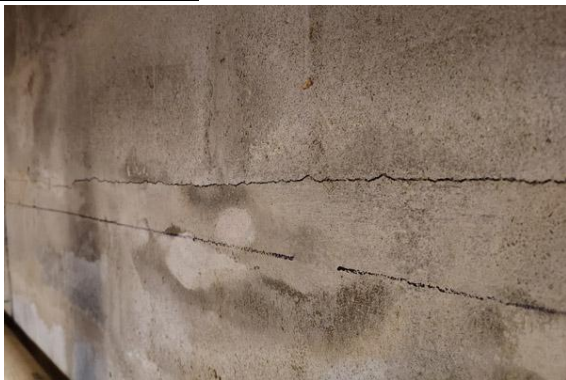
Rec ID 2066

3.1 (3) Structure : Main House : Interior : Foundation

Material Defect

Horizontal crack on the foundation found (back side)

Horizontal cracks are indicative of lateral pressure on the outside of the foundation.

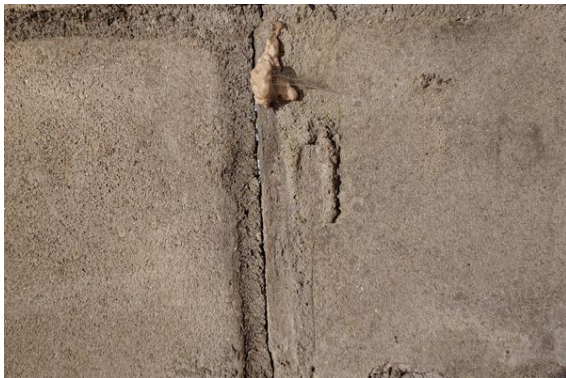
Rec ID 2087

3.1 (4) Structure : Main House : Interior : Foundation

As mentioned on the exterior foundation narrative, repointing is needed in a few areas in the interior portion as well.

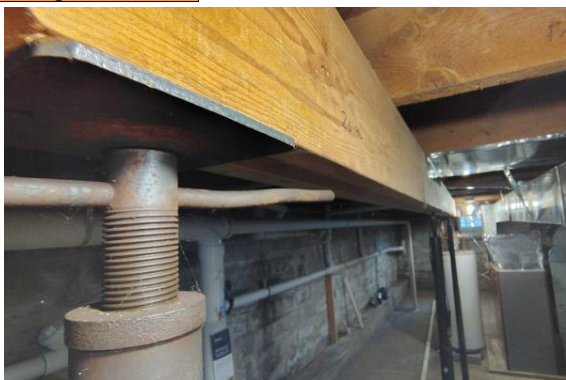
Rec ID 2085

3.1 (5) Structure : Main House : Interior : Foundation

Marginal Defect

Improper beam support

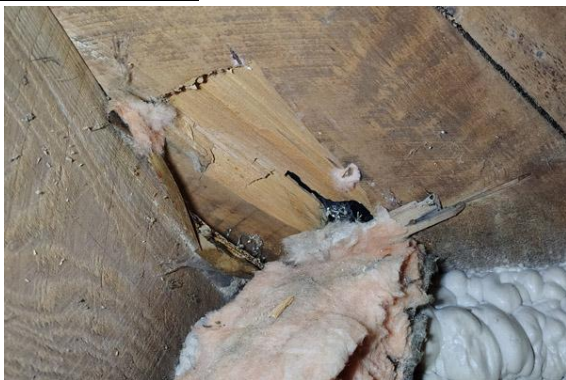
Rec ID 2044

3.2 (1) Structure : Main House : Interior : Framing

Minor Defect

First floor subfloor cracked and concealed.

Observed this subfloor with significant crack. I believe this may be under the kitchen cabinets.

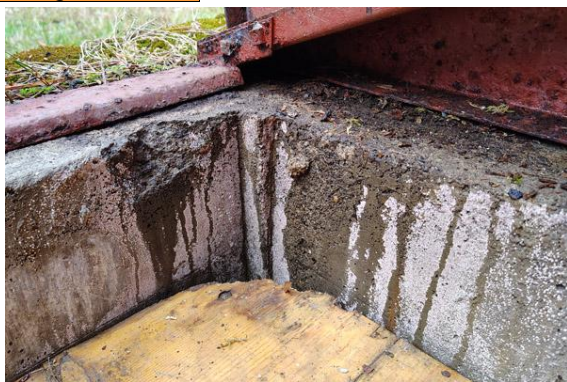
Rec ID 2045

3.3 (2) Structure : Main House : Interior : Foundation : Bulkhead

Marginal Defect

Active leak at corner of bulkhead

The bulkhead is actively leaking. This should be corrected before any more damage can occur. Currently the top tread on the stairs is rotted.

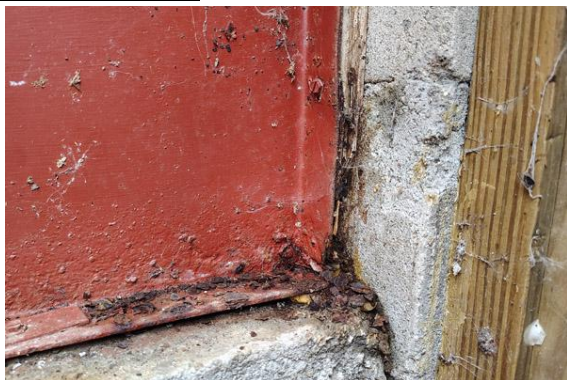
Rec ID 2046

3.3 (3) Structure : Main House : Interior : Foundation : Bulkhead

Marginal Defect

Corrosion and wood rot

The area where the bulkhead connects to the house foundation show advanced rot and corrosion. I recommend the removal and refinishing of the bulkhead.

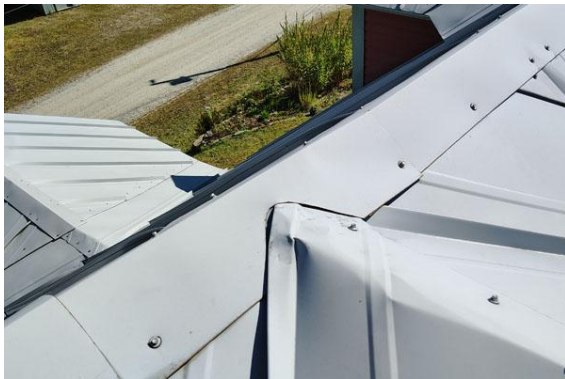
Rec ID 1205

Marginal Defect

Improper Installation

Roof was installed not using recommended installation practices. In this case it appears that the valleys were (top of the valley seen here against the ridge) installed using the standing seam panels rather than a valley panel. I've seen this type of roof installed this way on a few other homes but it should be noted that this installation is improper.

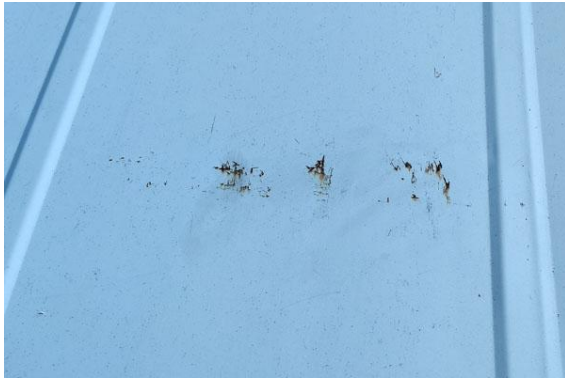
Rec ID 1206

4.1 (4) Structure : Main House : Exterior : Roof : Roof Covering

Marginal Defect

Roof scratch resulting in rust

There are a few spots on the roof that appear to have been scratched. Scratching the roof can lead to accelerated deterioration.

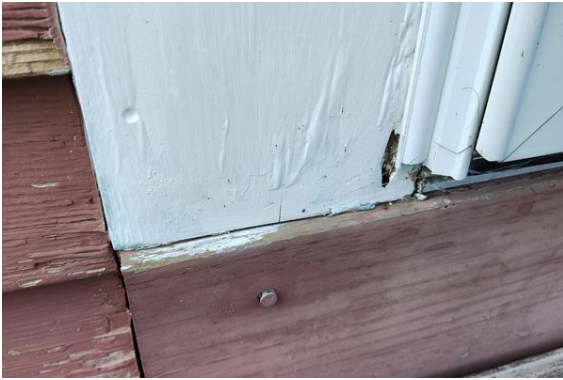
Rec ID 1036

5.1 (4) Structure : Main House : Exterior : Wall Covering : Siding/Trim

Material Defect

Trim was observed to be soft on the trim surrounding the entry door. This is not uncommon for a house of this age, This should be repaired to avoid water intrusion and further wood degradation.

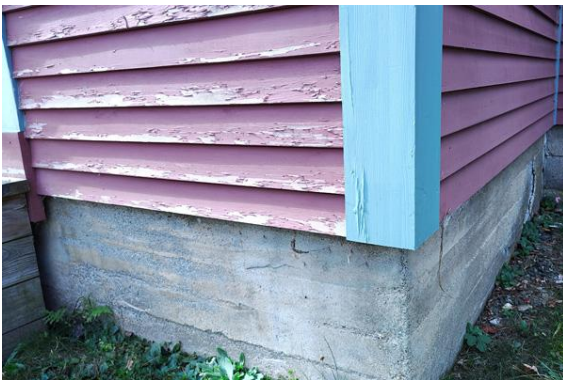
Rec ID 1037

Overall the house needs paint. Siding was observed to be weathered and checked in several areas. Paint is the first line of defense against weather.

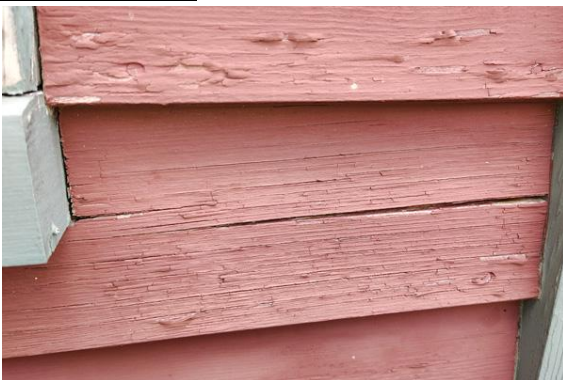
Rec ID 1050

Several areas are severely weathered from the lack of paint. Some clapboards should be replaced.

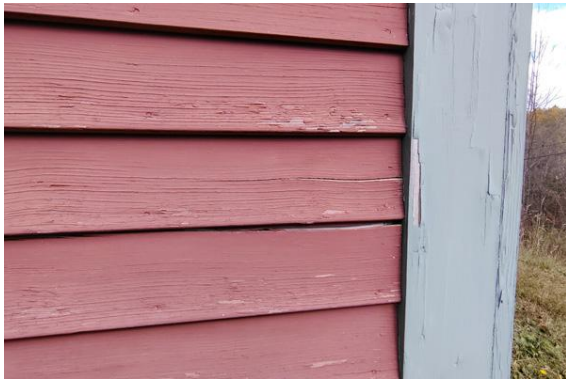
Rec ID 1052

More examples of weather worn siding and trim

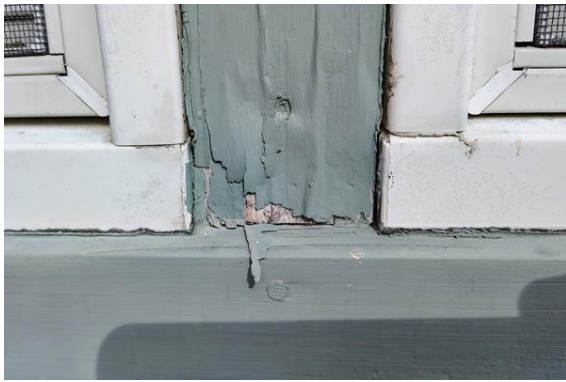
Rec ID 1054

Trim rot

More trim issues. This example is currently rotting and needs replacement.

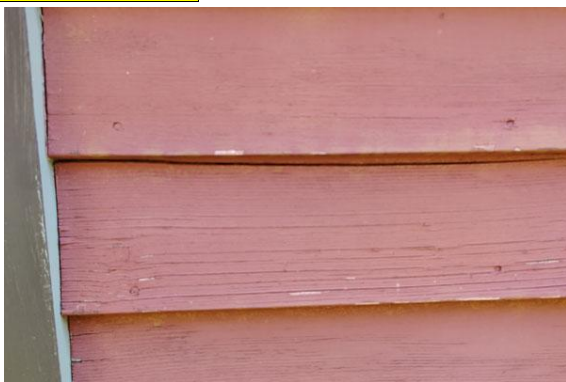
Rec ID 1181

Siding: siding shows signs of advanced age due to weathering

More examples of clapboard siding that should be replaced. The board is checked and would allow moisture to penetrate behind the siding.

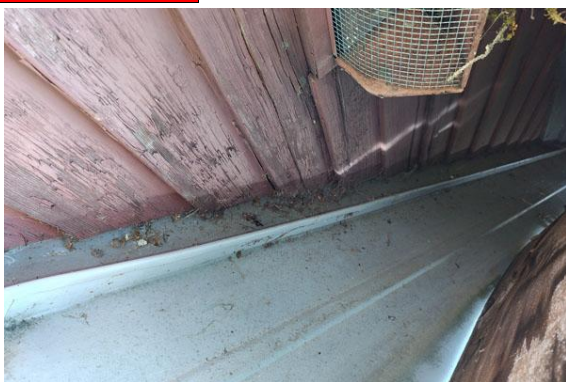
Rec ID 1191

Area behind plywood shows excessive weathering

More siding that appears to be at end of life due to lack of maintenance.

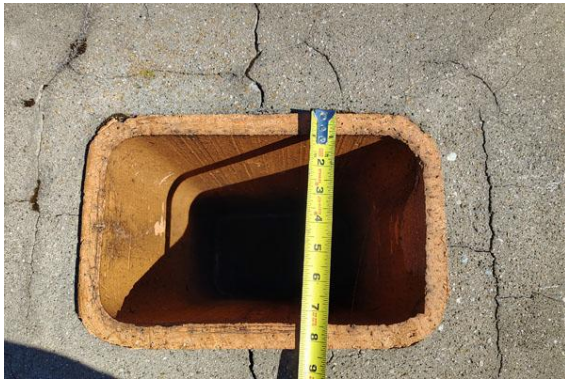
Rec ID 1201

Flashing and crown are deteriorating

There were a few areas on the chimney flashing that are cracked and allowing water to enter. This should either be sealed using silicone caulk (temporary) or the flashing should be redone (permanent). This should be evaluated/corrected by a chimney expert.

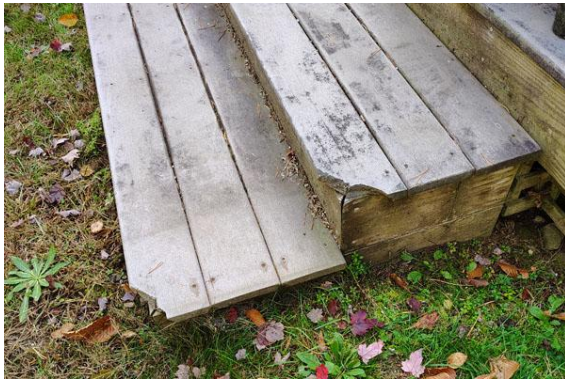
Rec ID 1187

Deck boards at end of life

The deck boards have reached end of life and should be replaced. Standard installation practice is to leave a gap between the deck boards to allow for expansion contraction and to allow moisture to escape. These were incorrectly installed tight together.

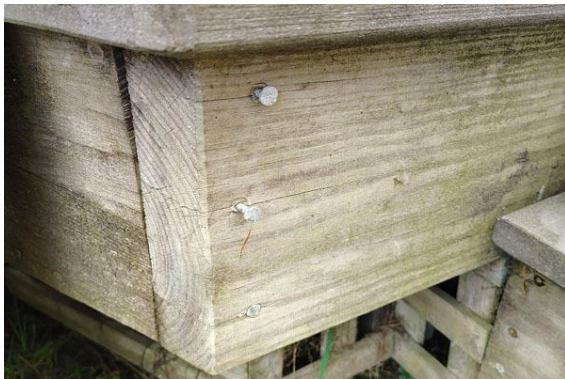
Rec ID 1182

Deck framing is becoming loose

The construction of the deck is becoming loose with age. These nails should be replaced with construction screws to assure a tight fit.

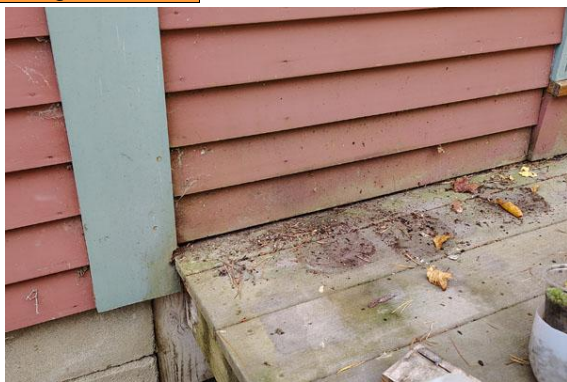
Rec ID 1185

Ledger flashing appears to be non-existent

The deck ledger is the board that connects the deck to the house. In a standard installation, this board is weatherproofed with flashing (see illustration). This needs to have appropriate flashing to prevent rot damage. Also, it is recommended to leave 2" gap between the deck surface and siding to prevent water from wicking up behind the siding.

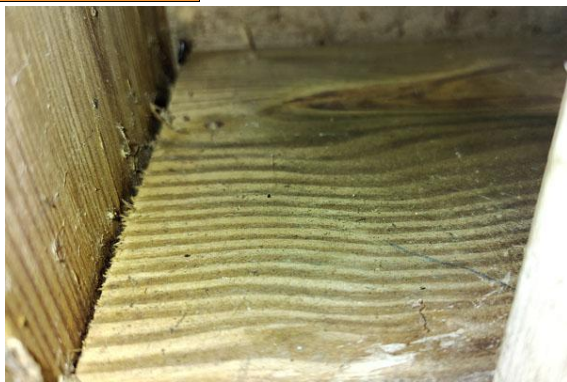
Rec ID 1186

No ledger flashing found

The deck was constructed without flashing to prevent moisture damage. This is the underside (left side) of the deck. I do not see any deterioration of the framing. Although the pressure treated lumber may have prevented any rot issues, even pressure treated wood will rot when exposed to water without allowing the structure to dry.

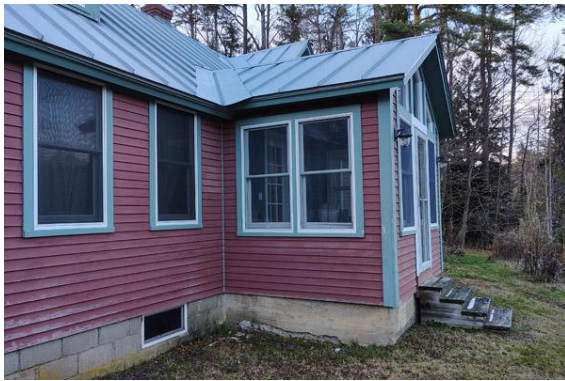
Rec ID 2133

Terrain sloped toward house

The terrain is sloped slightly toward the foundation In the area directly beneath the roof. This is also the area where the foundation spalling was observed. I recommend regrading the area around the house and possibly adding swales to move the water away from the house.

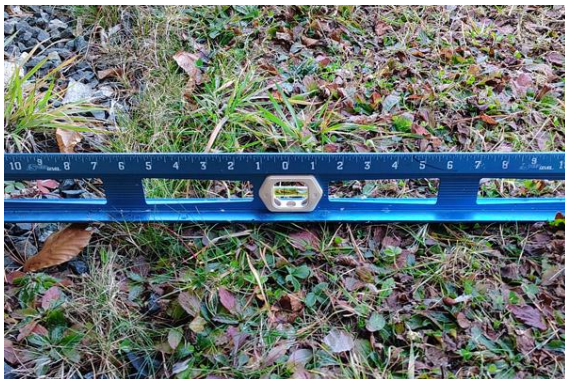
Rec ID 2134

Terrain sloped toward foundation

Several areas around the house are sloped toward the foundation. This should be corrected as water infiltration and hydrostatic pressure is a concern if not addressed.

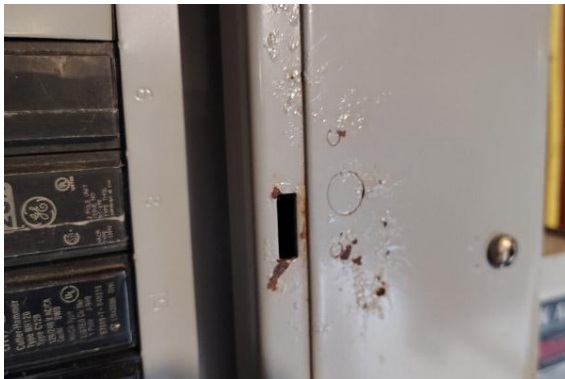
Rec ID 2055

The dead front is the front of the electric panel. It is removable (by screws) to gain access to the circuit breakers and wiring. I observed some corrosion in a couple areas of the panel. This was only on the cover, I did not see any corrosion in the panel itself.

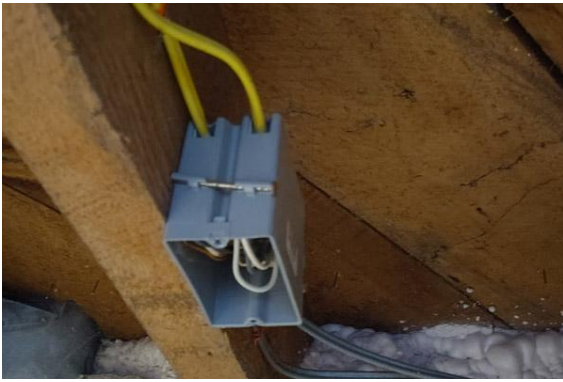
Rec ID 2053

Open junction box was found for the connection to the septic pump. This is a potential shock hazard if someone were to insert anything into the box. This is an easy fix by adding a blank switch plate cover.

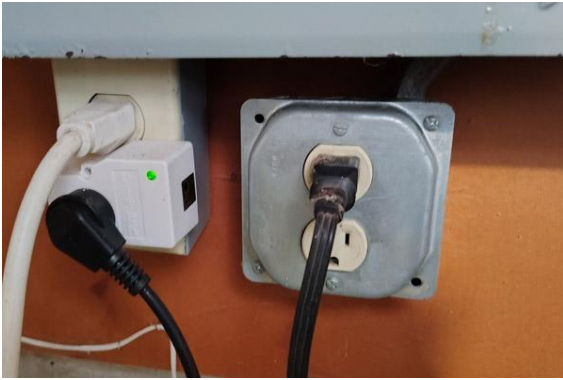
Rec ID 2051

Receptacles located in basements are required to be Ground Fault Circuit Interrupters (GFCI). This is to prevent shock hazards in case of a fault.

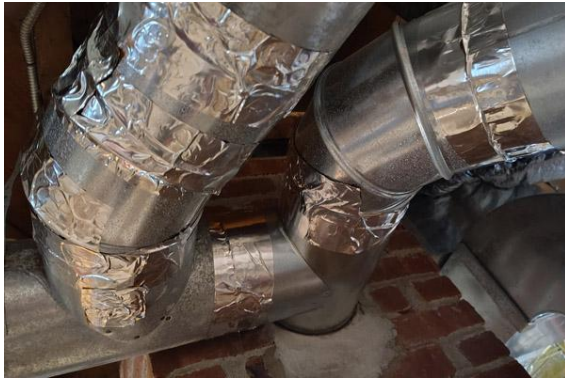
Rec ID 2072

13.9 (1) Mechanical : Main House : Appliance Venting

Marginal Defect

The water heater enters the vent using a 6" Tee fitting. This could cause combustion air spillage into the basement from the backdraft damper until proper draft is achieved up the chimney. This should be evaluated and corrected by a HVAC technician.

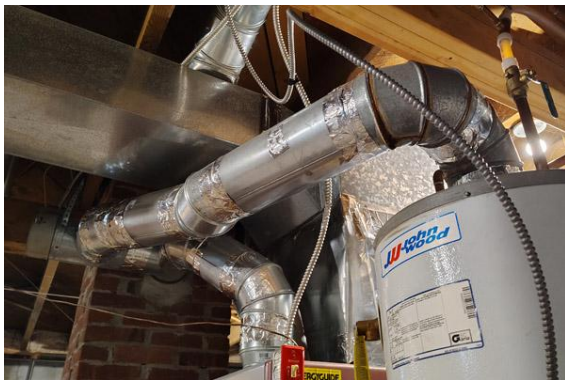
Rec ID 2071

The water heater is vented into a Tee fitting prior to entering the chimney. This could cause combustion air to backdraft out of the backdraft damper into the basement before proper draft is achieved up the chimney. This is a safety concern that should be addressed immediately. Recommendation: contact heating or plumbing contractor for repair.

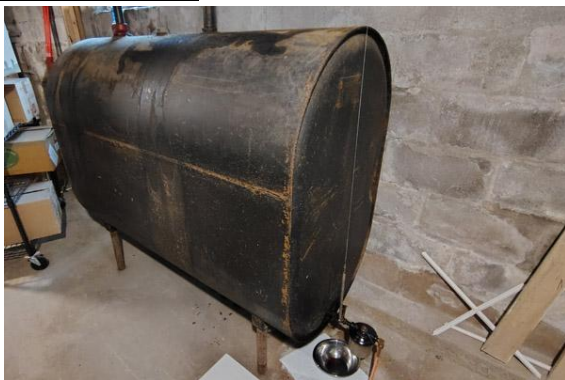
Rec ID 2073

The heating equipment and water heater is fueled with fuel oil. This is an older tank as is evidenced from the rust. The tank itself is not leaking however the fittings before the fuel filter exhibits a slow drip.

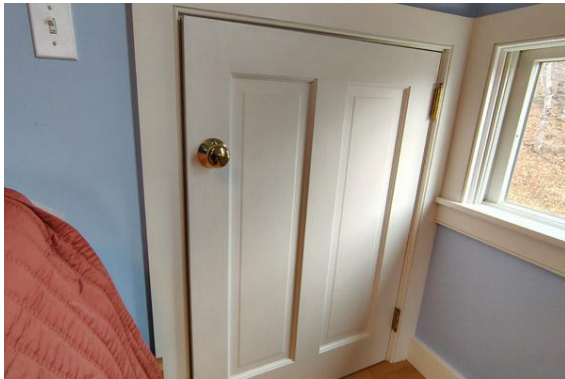
Rec ID 2095

Second Floor Bed: Closet Door

The small closet door closes with some difficulty. I did not observe any racking or evidence of repaired drywall in this area so this may be a simple installation defect and not a building defect.
