Inspection Report

24 Canterbury Tales
Chaucer, VT 02222

4/29/1387
2:30 PM

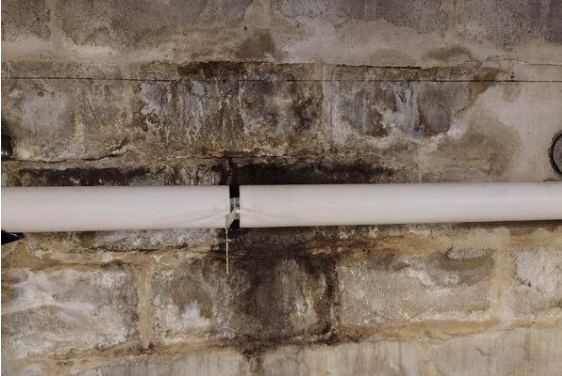
3.1 (1) Structure : Main House : Interior : Foundation

Water penetration observed

The foundation at the back of the house shows moisture penetration. This is the same area where the crack appears to be. Horizontal cracks are evidence of hydrostatic pressure on the foundation.

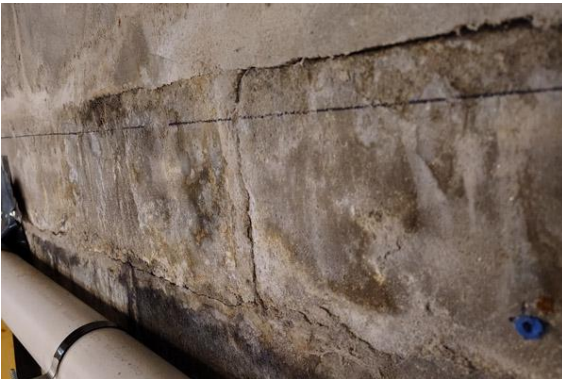
3.1 (2) Structure : Main House : Interior : Foundation

Horizontal crack on the foundation found (back side)

Horizontal cracks are indicative of hydrostatic pressure on the outside of the foundation. This is the area directly below the roof in the inside corner of the back porch and house meet. This crack runs about 15-20 feet wide. I recommend that a structural engineer evaluate the condition.

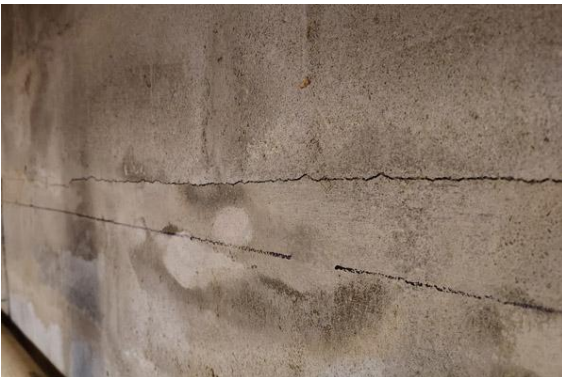
3.1 (3) Structure : Main House : Interior : Foundation

Horizontal crack on the foundation found (back side)

Horizontal cracks are indicative of lateral pressure on the outside of the foundation.

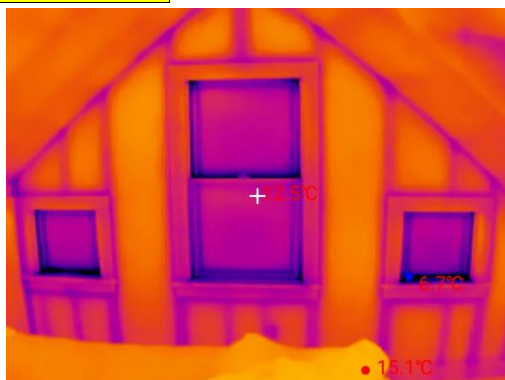
Missing Framing

Thermal imaging revealed missing framing over the windows in the bedrooms. This image is from the blue bedroom (north). In typical wall construction, headers are installed over openings in the wall to distribute the roof load around the openings. Although there are missing framing elements, it does not appear that any sagging has occurred.

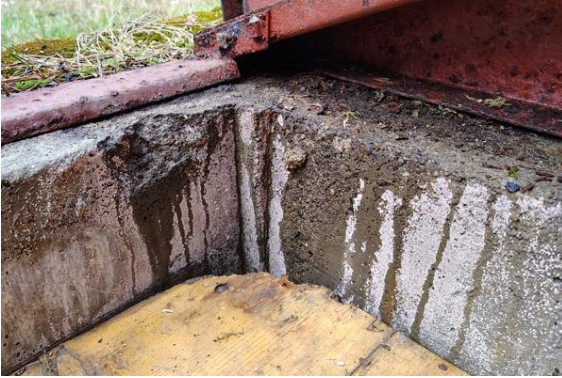
3.3 (2) Structure : Main House : Interior : Foundation : Bulkhead

Active leak at corner of bulkhead

The bulkhead is actively leaking. This should be corrected before any more damage can occur. Currently the top tread on the stairs is rotted.

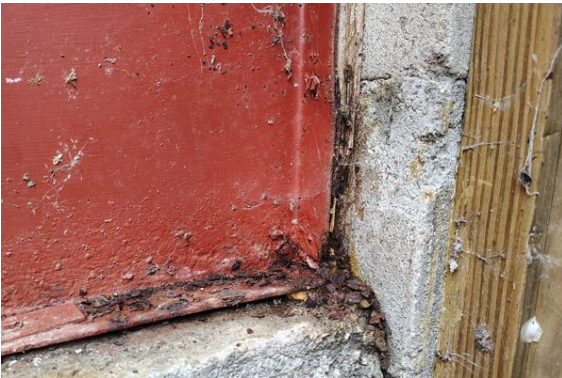
3.3 (3) Structure : Main House : Interior : Foundation : Bulkhead

Corrosion and wood rot

The area where the bulkhead connects to the house foundation show advanced rot and corrosion. I recommend the removal and refinishing of the bulkhead.

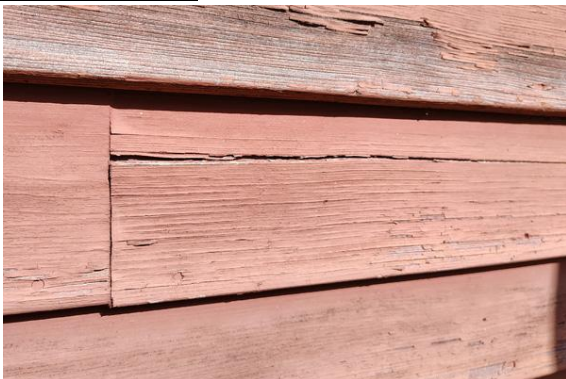
5.1 (2) Structure : Main House : Exterior : Wall Covering : Siding/Trim

There are several areas of the siding that are cracked or checked. This appears to be due to the lack of maintenance (paint). This image is from the right(south)side of the house.

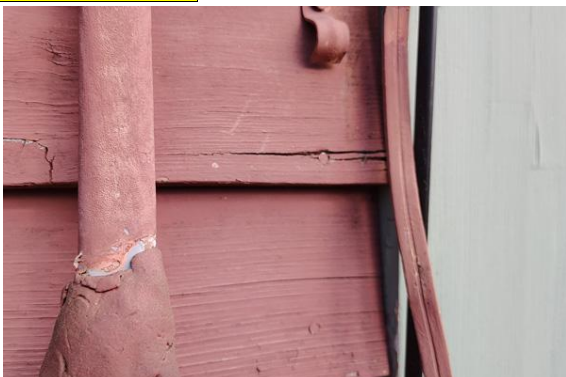
5.1 (3) Structure : Main House : Exterior : Wall Covering : Siding/Trim

Cracked/Checked siding

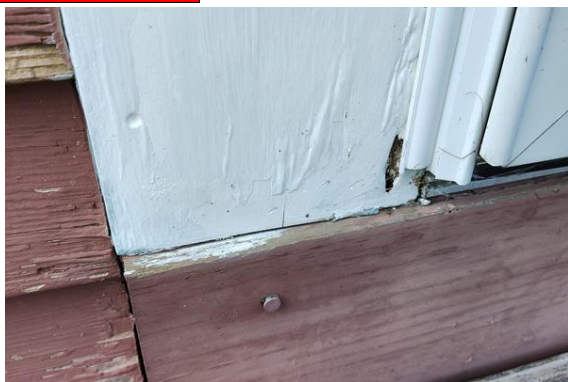
5.1 (4) Structure : Main House : Exterior : Wall Covering : Siding/Trim

Trim was observed to be soft on the trim surrounding the entry door. This is not uncommon for a house of this age, This should be repaired to avoid water intrusion and further wood degradation.

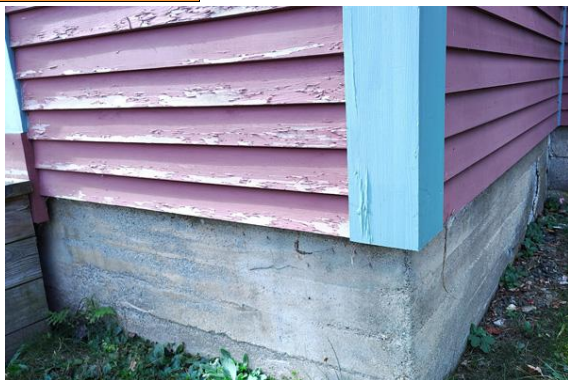
5.1 (5) Structure : Main House : Exterior : Wall Covering : Siding/Trim

Overall the house needs paint. Siding was observed to be weathered and checked in several areas. Paint is the first line of defense against weather.

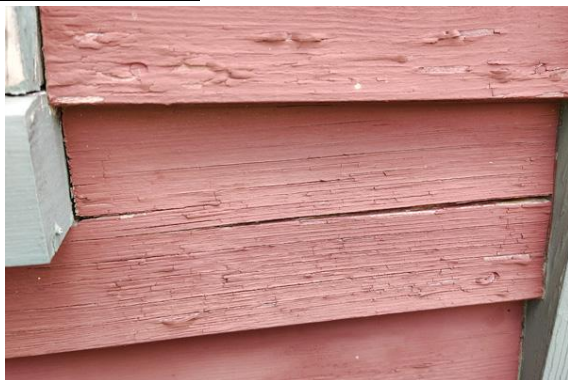
5.1 (7) Structure : Main House : Exterior : Wall Covering : Siding/Trim

Several areas are severely weathered from the lack of paint. Some clapboards should be replaced.

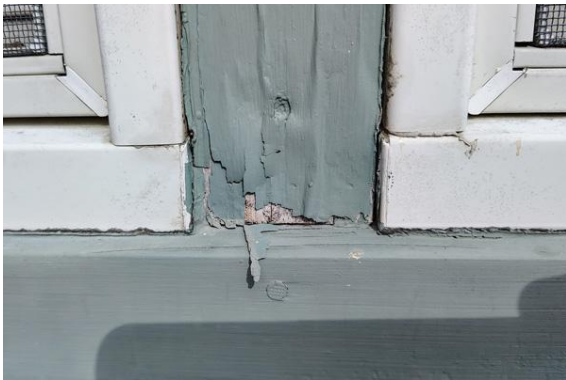
5.1 (9) Structure : Main House : Exterior : Wall Covering : Siding/Trim

Trim rot

More trim issues. This example is currently rotting and needs replacement.

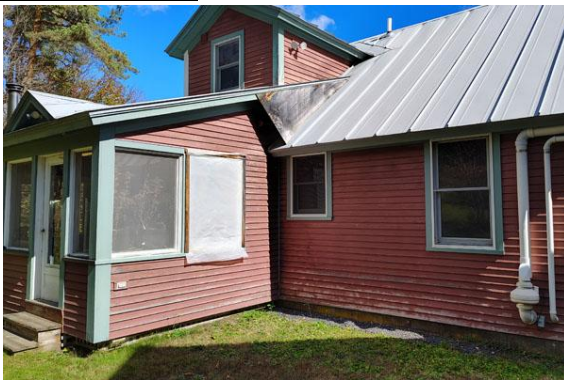
5.1 (14) Structure : Main House : Exterior : Wall Covering : Siding/Trim

Back of house shows a plywood installed presumably to mitigate further damage due to rain water coming off the dormer roof and splashing off of the lower roof and onto the siding. This would keep the area below the dormer roof wet and lead to advanced weathering.

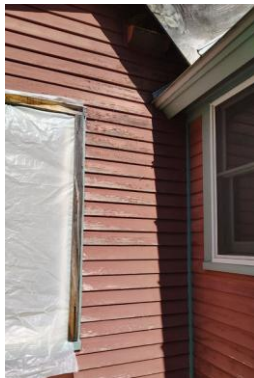
5.1 (15) Structure : Main House : Exterior : Wall Covering : Siding/Trim

Closer up of damage likely caused from the water splashing down from the roof above. As discussed in the above narrative.

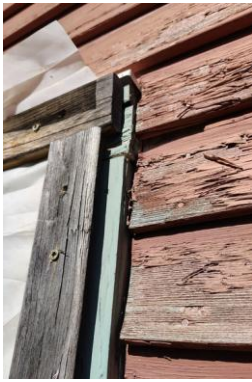
5.1 (16) Structure : Main House : Exterior : Wall Covering : Siding/Trim

Siding and trim excessive weathering

Back Porch siding shows excessive weathering. Because of the lack of maintenance over the years, this should be evaluated by a siding professional

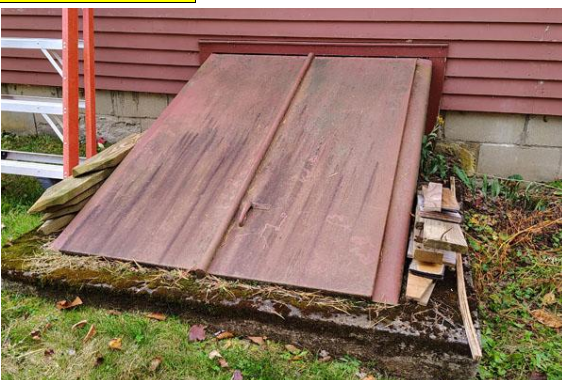
Bulkhead moss growth

Moss growth was observed around the bulkhead door. Moss will hold water longer creating an opportunity for rot. Moss should be taken care of at least on an annual basis. Moss retains moisture creating an opportunity for wood deterioration (rot) to occur.

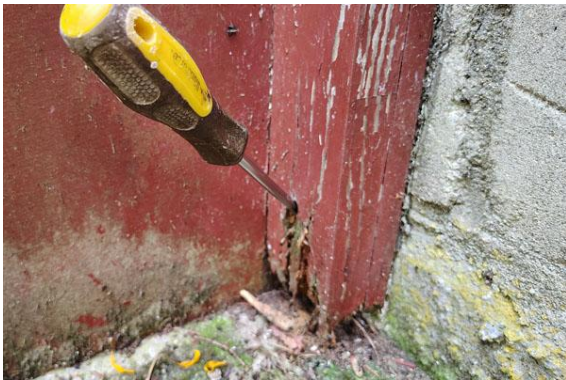
5.1 (21) Structure : Main House : Exterior : Wall Covering : Siding/Trim

The trim surrounding the bulkhead has rotted. This should be replaced and sealed as moisture could find it's way into the basement door area.

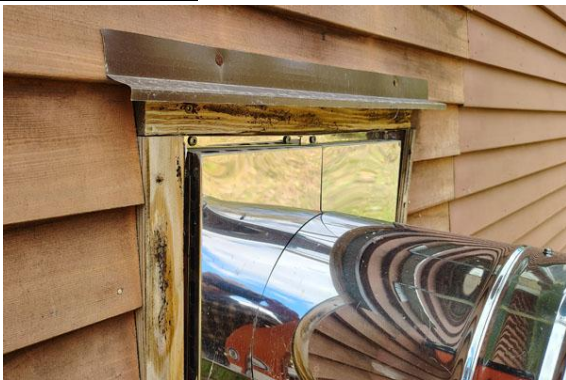
5.1 (22) Structure : Main House : Exterior : Wall Covering : Siding/Trim

Flashing was installed incorrectly. This could allow water to enter behind the opening for the chimney.

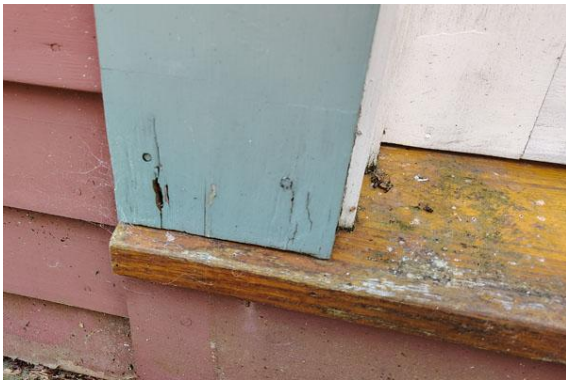
5.1 (23) Structure : Main House : Exterior : Wall Covering : Siding/Trim

Trim boards at the base of the deck door show signs of rot. These should be replaced to prevent further damage and moisture entry.

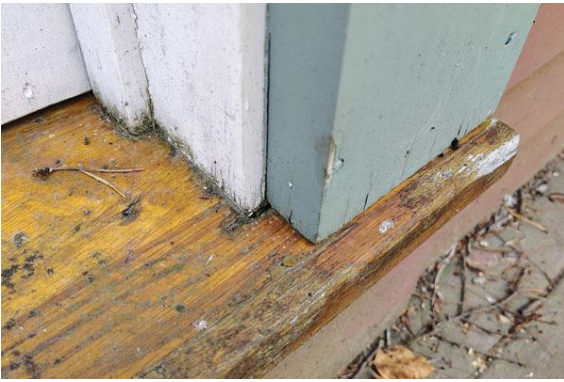
5.1 (24) Structure : Main House : Exterior : Wall Covering : Siding/Trim

Continuing the discussion of trim board replacement, these should be addressed.

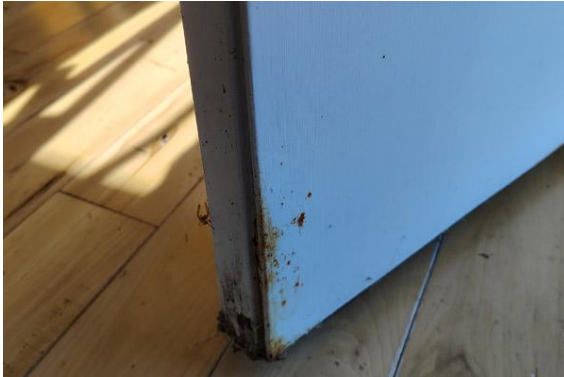
Front door has rust at the bottom.

I observed some surface rust on the bottom of the front door. This should be scrapped and repainted to protect the door materials. The storm door appears to be newly installed. This is a great first line of defense for protecting expensive exterior doors.

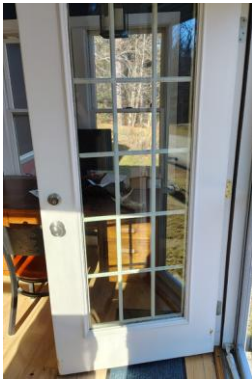
6.1 (2) Structure : Main House : Exterior : Windows/Doors : Condition

Front Door shows minor wear from weathering. The door latch does not engage easily.

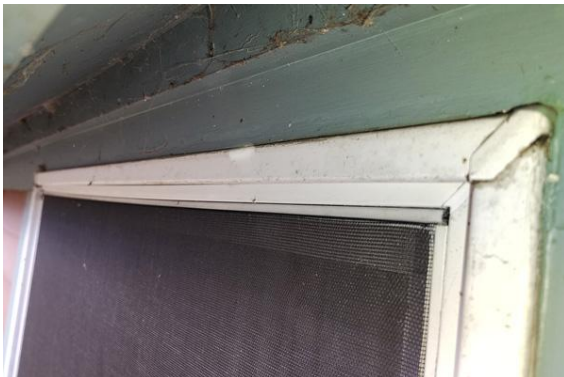
6.2 (1) Structure : Main House : Exterior : Windows/Doors : Flashing

Windows missing flashing

Missing flashing was observed on both sides windows directly under overhang on both sides. Although this area is less prone to water intrusion, flashing is required avoid wind driven rain from getting behind the trim.

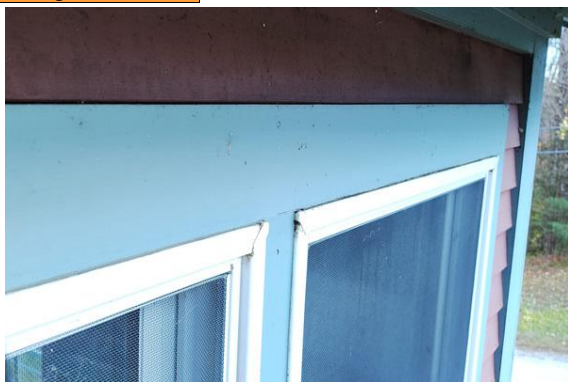
6.2 (2) Structure : Main House : Exterior : Windows/Doors : Flashing

More missing flashing

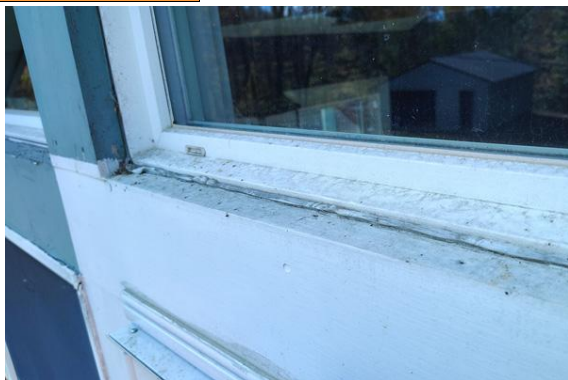
6.2 (3) Structure : Main House : Exterior : Windows/Doors : Flashing

Windows: missing flashing

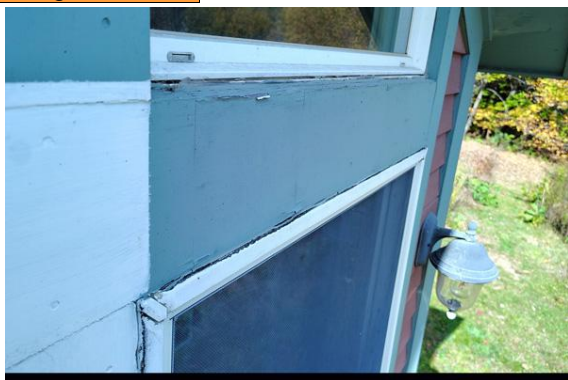
6.2 (4) Structure : Main House : Exterior : Windows/Doors : Flashing

Windows: missing flashing

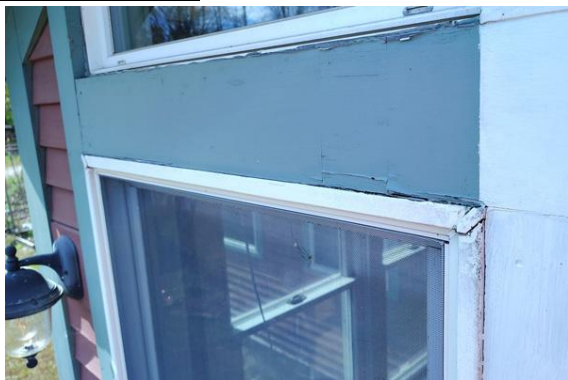
6.2 (5) Structure : Main House : Exterior : Windows/Doors : Flashing

Windows/Trim missing flashing

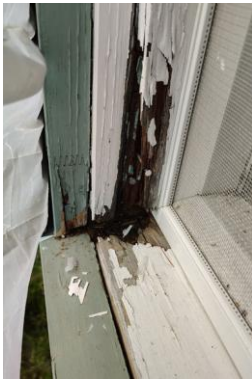
6.2 (6) Structure : Main House : Exterior : Windows/Doors : Flashing

The window beneath the poly film has advance rot. This should be addressed sooner than later to prevent further damage to the wall system.

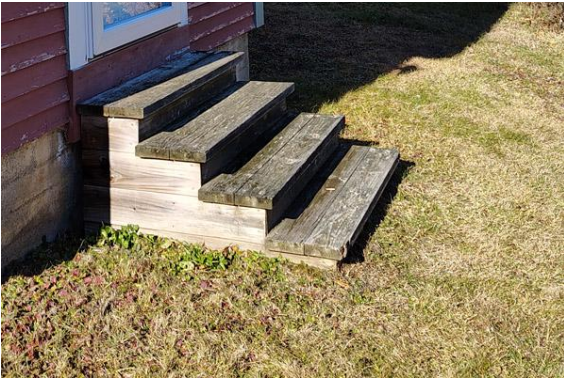
Rec ID 2140

Front entry steps are built with pressure treated lumber, They are old but appear to be functional. On visual inspection and walking on the treads, they appear to be solid. There should be a landing in front of the door, however to accommodate the outswing of the storm door.

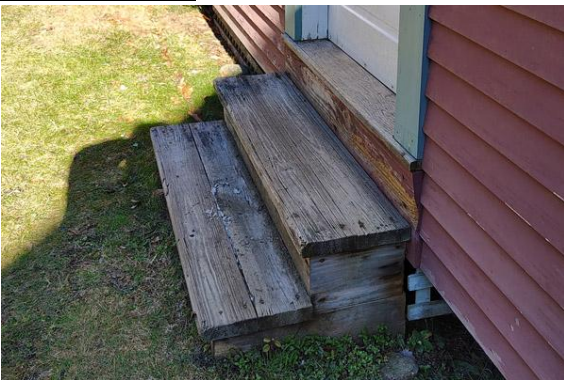
Rec ID 2139

The back steps are constructed the same as the front. No issues, just old.

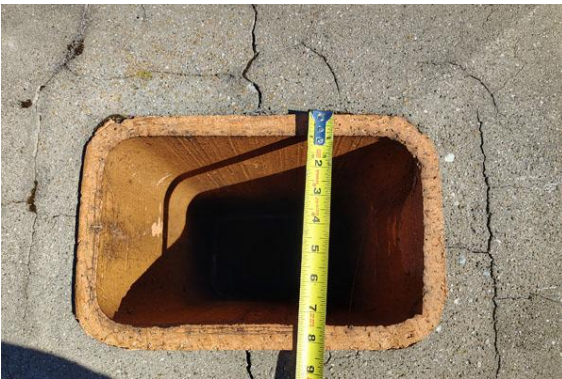
Rec ID 1201

Chimney crown and flue at end of life

As identified above the crown needs to be redone with a proper 3-4" thick poured concrete crown. The terra cotta flue liner also will need to be extended so that it is a minimum of 4" above the new crown.

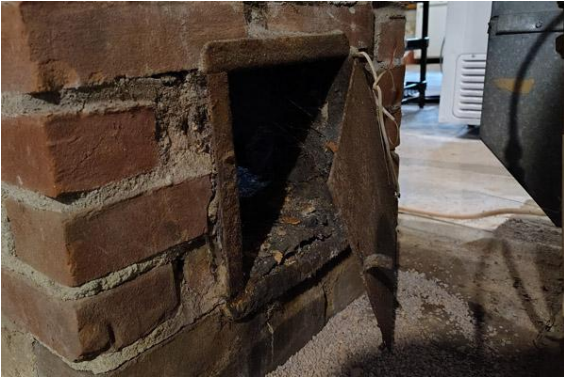
Rec ID 2049

Chimney access door needs replacement

The hinges on the chimney clean out door are broken. This should be replaced.

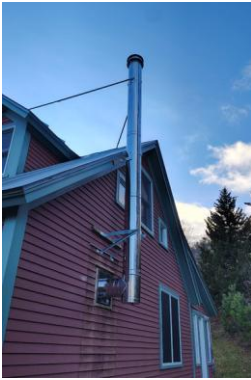
Rec ID 2135

Chimney rises above roof in accordance with standards. 10-3-2 rule, minimum 3' clearance above roof and at least 2' above anything that is within 10' of the chimney.

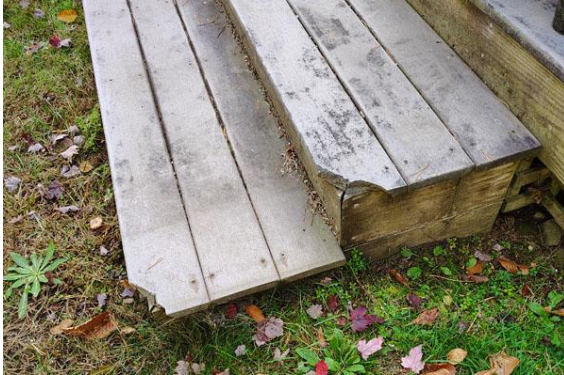
Rec ID 1187

Deck boards at end of life

The deck boards have reached end of life and should be replaced. Standard installation practice is to leave a gap between the deck boards to allow for expansion contraction and to allow moisture to escape. These were incorrectly installed tight together.

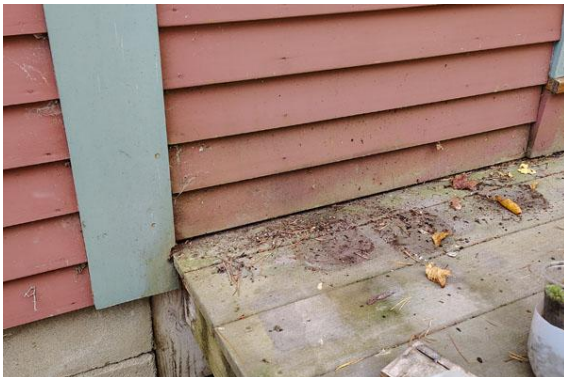
Rec ID 1185

Ledger flashing appears to be non-existent

The deck ledger is the board that connects the deck to the house. In a standard installation, this board is weatherproofed with flashing (see illustration). This needs to have appropriate flashing to prevent rot damage. Also, it is recommended to leave 2" gap between the deck surface and siding to prevent water from wicking up behind the siding.

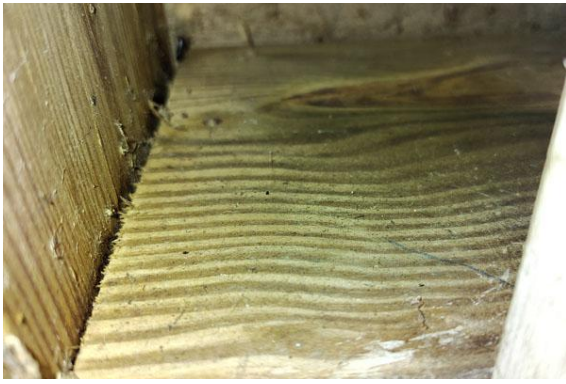
Rec ID 1186

No ledger flashing found

The deck was constructed without flashing to prevent moisture damage. This is the underside (left side) of the deck. I do not see any deterioration of the framing. Although the pressure treated lumber may have prevented any rot issues, even pressure treated wood will rot when exposed to water without allowing the structure to dry.

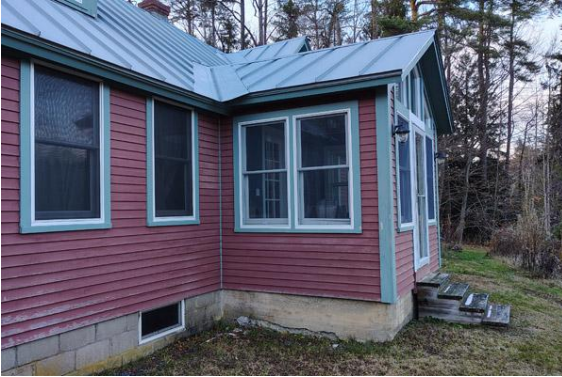
Rec ID 2133

Terrain sloped toward house

The terrain is sloped slightly toward the foundation In the area directly beneath the roof. This is also the area where the foundation spalling was observed. I recommend regrading the area around the house and possibly adding swales to move the water away from the house.

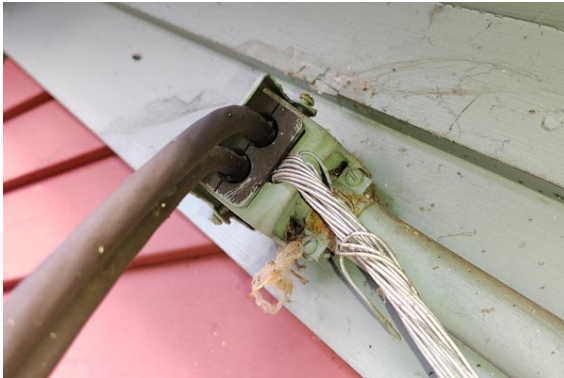
Rec ID 1227

Service Entrance neutral conductor frayed

The service entrance, where it runs through the weather head, shows a frayed neutral conductor. The reduction in cable size due to the frayed strands reduce the total ampacity of this conductor. This should be repaired by an electrician.

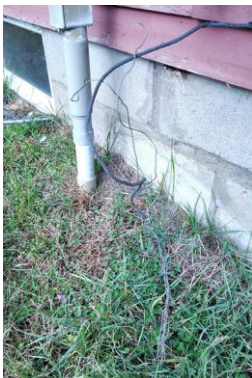
Rec ID 2040

Ground wire frayed.

The ground wire is frayed where it enters the soil to connect to the ground rods. This conductor should be better protected, as lawn equipment can easily cause damage. Correction by a licensed electrician is recommended.

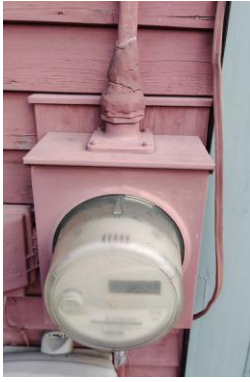
Rec ID 1216

The clay weather seal is cracked and should be replaced

Clay is used to seal the service entrance at the meter box. Over time, this seal can dry out and deteriorate, which may allow water to enter the meter box and cause corrosion.

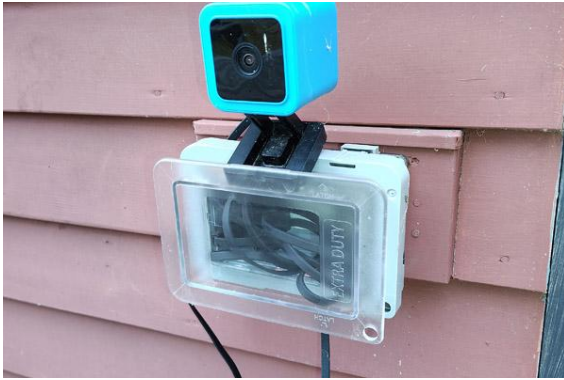
Rec ID 2041

With the camera on the receptacle, I could not test the functionality receptacle.

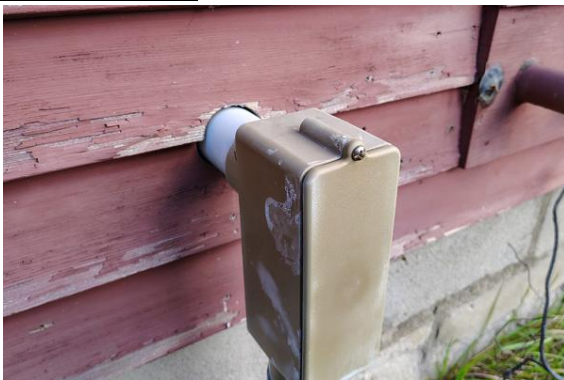
Rec ID 1215

Missing sealant was observed at the outbuilding feeder penetratio

Sealant should be applied at all penetrations through the building envelope. This penetration supplies the feeder circuit to the garage. Proper sealing is important to prevent exterior air and moisture from entering the wall system.

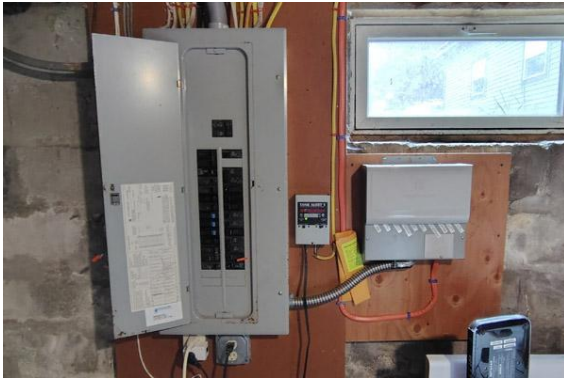
Rec ID 2054

Overall picture of main panel and generator connection

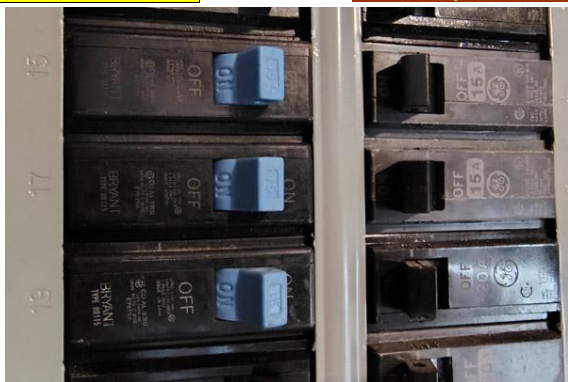
Rec ID 2060

I observed 4 different breaker brands being used in this panel. Generally, electric panels are only spec'd to use their own branded breakers. This is to ensure that full amperage can be achieved in the connection between the breaker to the buss bar. I observed 4 different breaker brands being used in this panel. This should be evaluated and/or corrected by an licensed electrician.

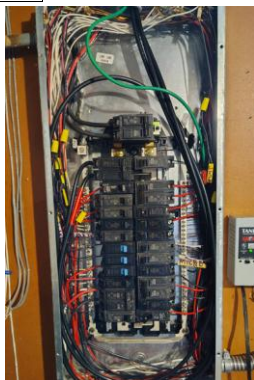
Rec ID 2058

Main Panel with dead front off,

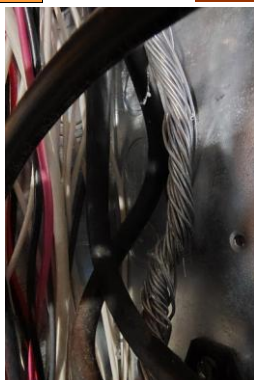
Rec ID 2057

I observed the neutral conductor inside the main panel is frayed. This could impact the total ampacity that this conductor can carry. I recommend a licensed electrician evaluate and correct.

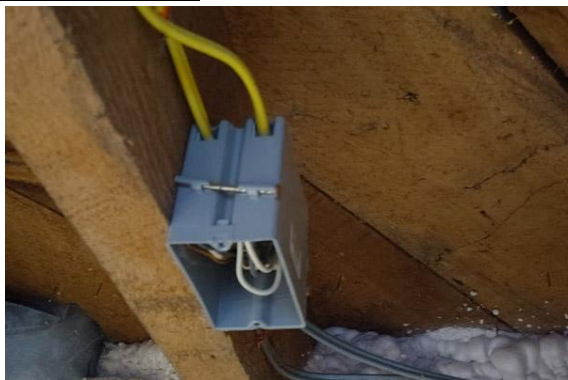
Rec ID 2053

Open junction box was found for the connection to the septic pump. This is a potential shock hazard if someone were to insert anything into the box. This is an easy fix by adding a blank switch plate cover.

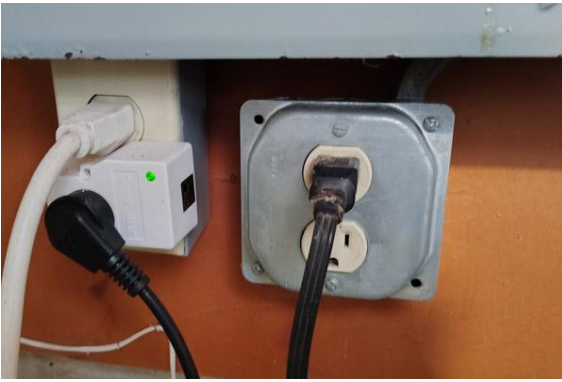
Rec ID 2051

Receptacles located in basements are required to be Ground Fault Circuit Interrupters (GFCI). This is to prevent shock hazards in case of a fault.

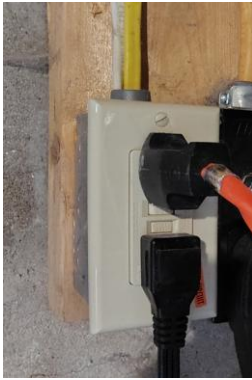
Rec ID 2052

Typically 12 AWG wire is needed for a 20 amp circuit. When tapping into existing circuits, it's best practice to use the same gauge wire to ensure that the wire is protected by the correct amperage circuit breaker. This 14 AWG feeds a single load, a radon air pump that draws 60 watts.

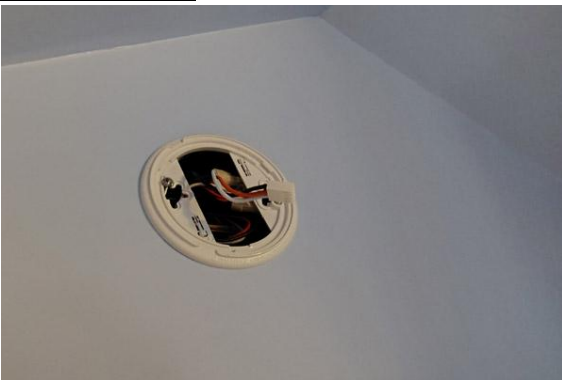
Rec ID 2097

Second Floor Bedroom - Missing Smoke/CO detector

I observed missing smoke detectors in the upstairs blue bedroom and wall in the common area outside of the bedrooms. Smoke/CO alarms are necessary to alert to a potential life threatening event.

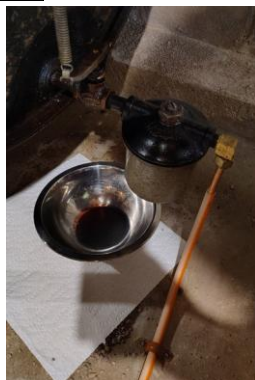
Rec ID 2070

Slow drip from oil tank valve connection

I observed a known oil drip coming from the connections off the fuel oil tank. This should be corrected by heating or plumbing contractor.

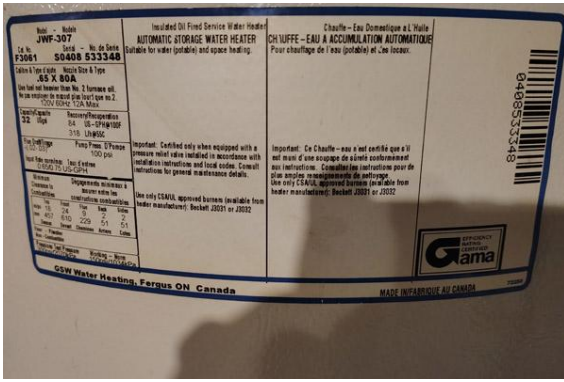
Rec ID 2081

32 gallon tank, 55k BTU input

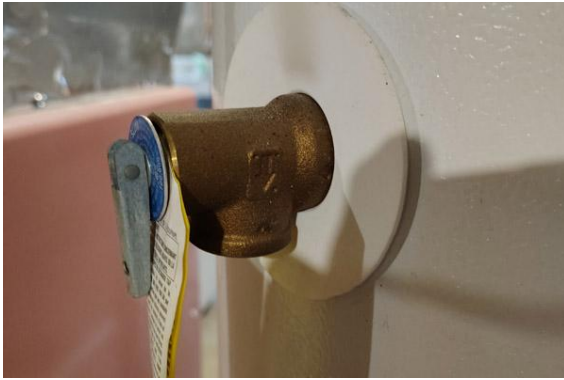
Rec ID 2080

Missing discharge pipe on water heater TPR valve.

The TPR (Temperature & Pressure Relief) valve is missing the discharge pipe. This pipe is necessary to avoid spraying hot water in the event of the release of water. This is an easy fix but a safety defect.

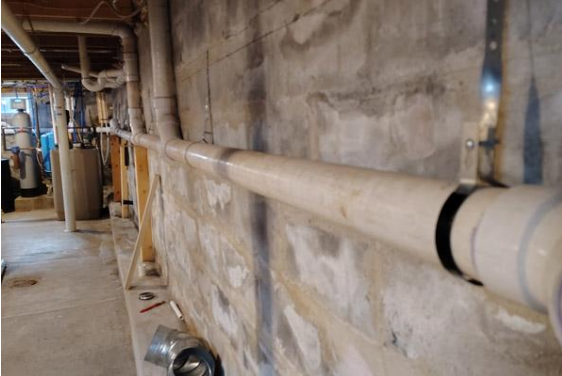
Rec ID 2079

The main drain appears to have temporary support along the length of the pipe. It should be secured with a more permanent solution.

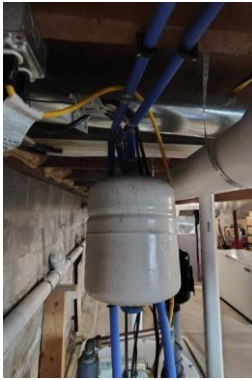
Rec ID 2074

There is a small expansion tank above the radon bubbler. This is only hanging on the pex plumbing. This should be supported on its own.

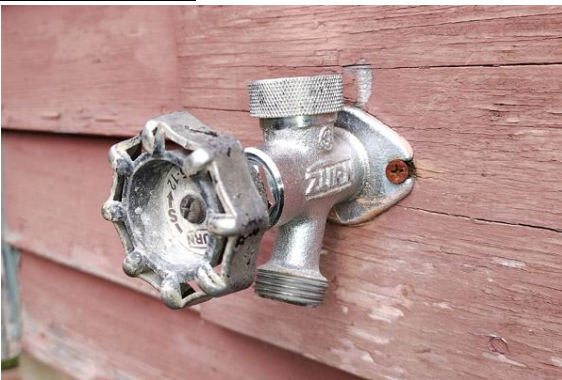
Rec ID 2043

Frost resistant outdoor spigot - operational

Backflow preventer is present but untested

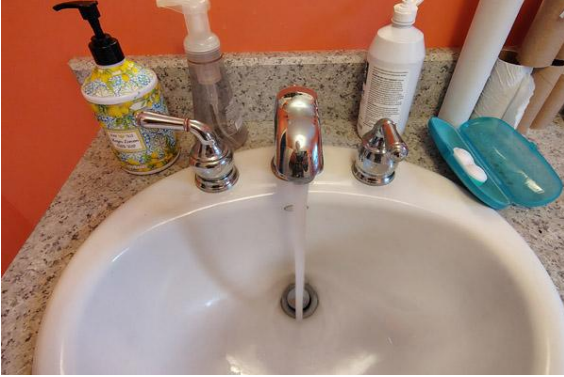
Rec ID 2112

No issues found, operated as expected, drained quickly

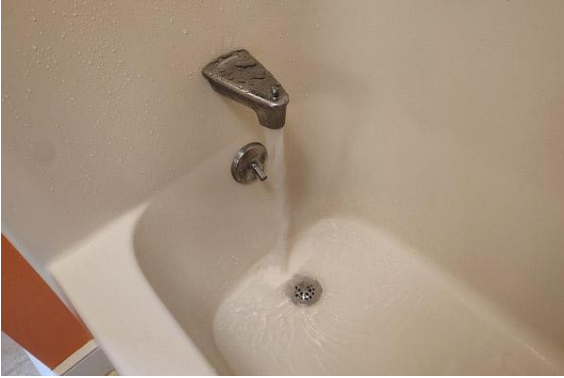
Rec ID 2114

Second Floor Bath - Tub Faucet

No issues found, faucet operated as expected; diverter valve OK. Slightly slow drain.

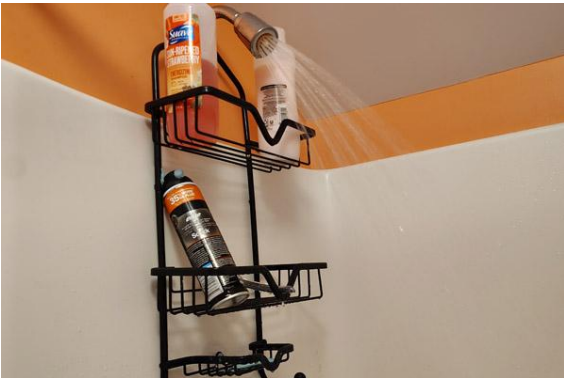
Rec ID 2110

No issues found, shower head operated as expected.

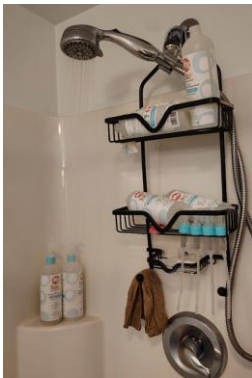
Rec ID 2130

Faucet and drain function as expected, no issues

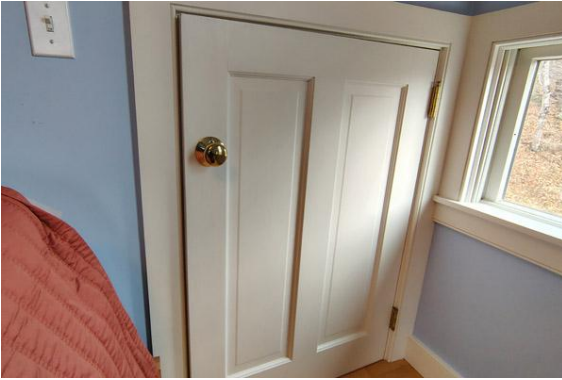
Rec ID 2095

The small closet door closes with some difficulty. I did not observe any racking or evidence of repaired drywall in this area so this may be a simple installation defect and not a building defect.

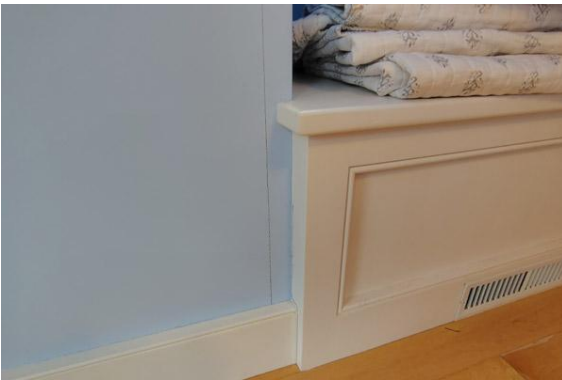
Rec ID 2093

Second Floor Bedroom - Crack in drywall cornerbead

I observed a crack in the drywall next to the seat under the dormer area. No other evidence but keep an eye on it to verify that the crack doesn't widen.

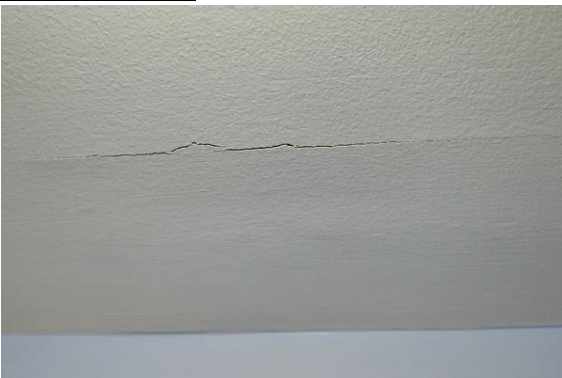
Rec ID 2122

Drywall crack in ceiling of first floor blue bedroom

I observed a small crack in the ceiling drywall. Sometimes a crack is only a crack and not evidence of something bigger. Recommendation is to monitor.

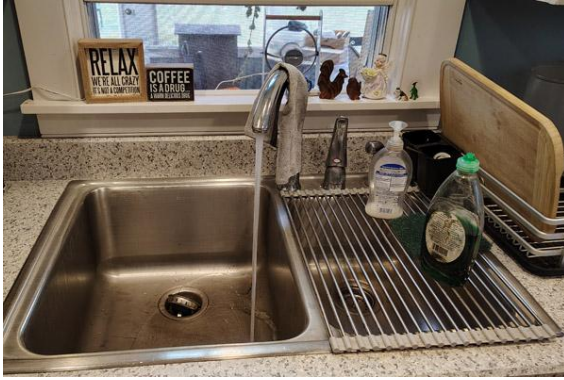
Rec ID 2127

Kitchen faucet/sprayer functions as expected

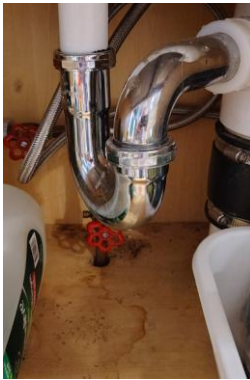
Rec ID 2123

Evidence of leaking drain.

The kitchen drain shows evidence that it has leaked. While not currently wet after running water, it should be monitored to verify there is no active leak.

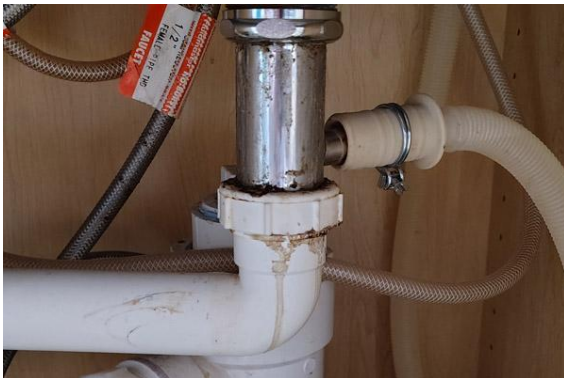
Rec ID 2126

Possible leak in drain under smaller sink

I observed a potential leak in the drain of the smaller of the two bay kitchen sink. It was not actively wet (may have already been repaired) but keep an eye on to verify that the fittings no longer leak.

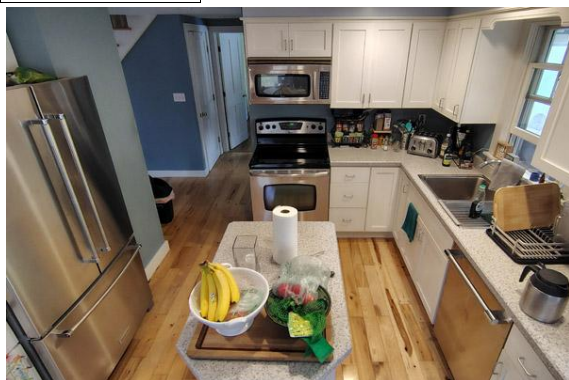
Rec ID 2125

Lighting is very good.

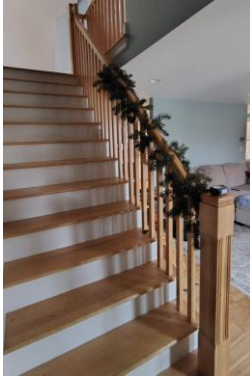
Rec ID 2103

No issues

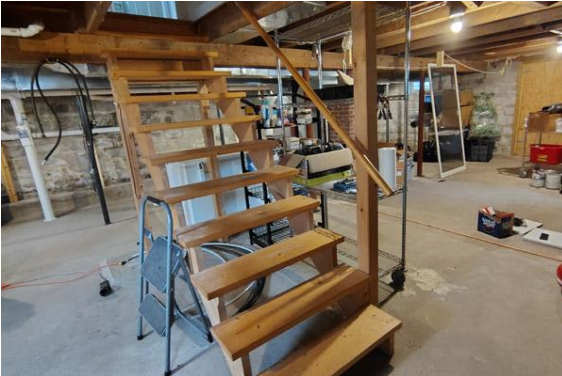
Rec ID 2091

I observed missing balusters & missing risers. This is a safety concern as a small child could fall through the open areas of the staircase.

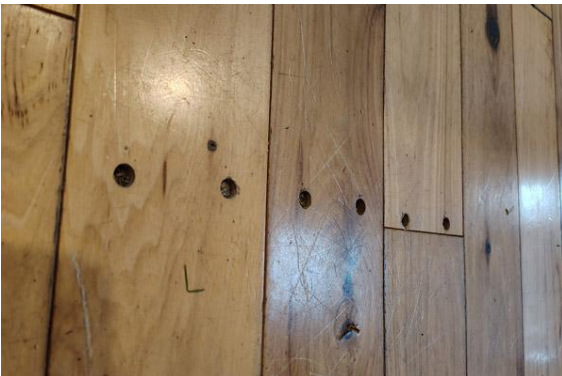
Rec ID 2131

I observed that the floor is slightly "wavy" and a few portions were resecured. This might be indicative of wood expansion from humidity and moisture. The wood species on the first floor's floor is hickory. Hickory is known to have large expansion characteristics with seasonal changes.

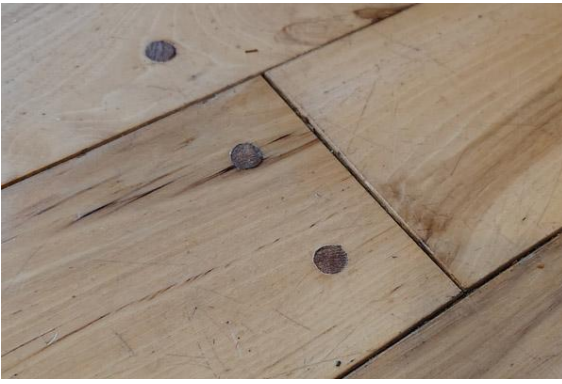
Rec ID 2132

Floor resecured.

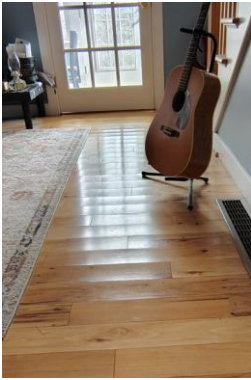
Rec ID 2128

The hardwood floor exhibits cupping. This may have been installation defect or could indicate excessive moisture.

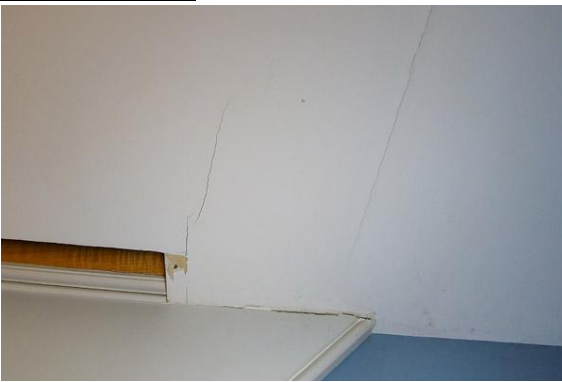
Rec ID 2101

Cracked Drywall - First Floor Ceiling

I observed some drywall cracks that occurred next to the stairs and on the other side of the kitchen along the same line (middle of house).

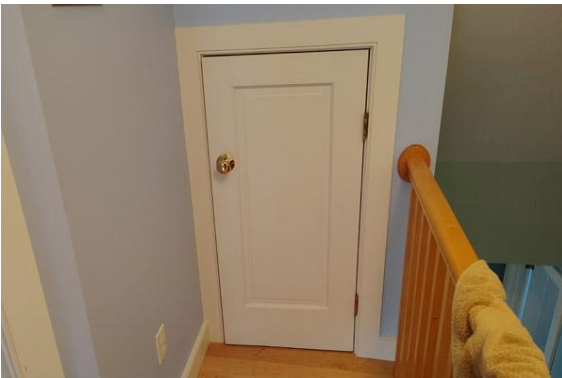
Rec ID 2102

The closet door has a tight fit requiring slight force to close. There was no racking observed indicating that this most likely was an install defect.
