hepburnhomeinspections.com

Inspection Report

24 Canterbury Tales
Chaucer, VT 02222

Inspection Type: Pre-Purchase

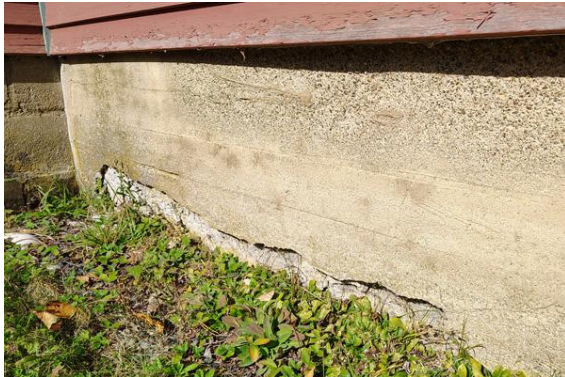
2.1 (2) Structure : Main House : Exterior : Foundation

Foundation : Spalling concrete

Spalling is a condition of concrete where the concrete begins to flake off. This is commonly caused by freeze/thaw cycles. Spalling was observed on both sides of the foundation around the front porch. This is likely caused by the lack of water management from the roof. This should be evaluated by a structural engineer specializing in foundation systems.

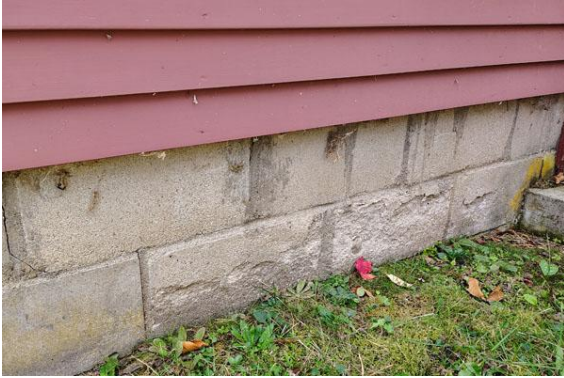
2.1 (4) Structure : Main House : Exterior : Foundation

Foundation spalling

More spalling concrete found. This was observed on the right (North) side.

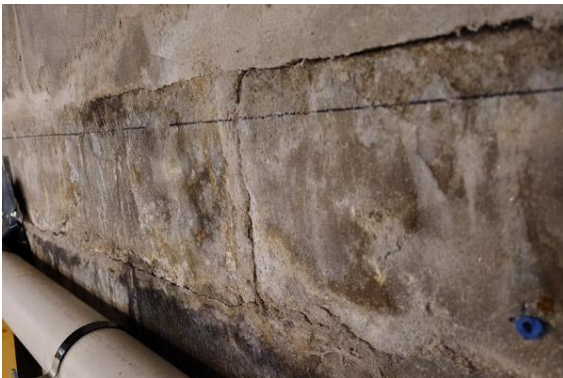
3.1 (2) Structure : Main House : Interior : Foundation

Horizontal crack on the foundation found (back side)

Horizontal cracks are indicative of hydrostatic pressure on the outside of the foundation. This is the area directly below the roof in the inside corner of the back porch and house meet. This crack runs about 15-20 feet wide. I recommend that a structural engineer evaluate the condition.

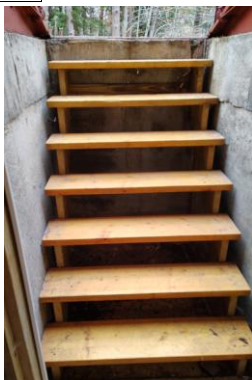
3.3 (2) Structure : Main House : Interior : Foundation : Bulkhead

Active leak at corner of bulkhead

The bulkhead is actively leaking. This should be corrected before any more damage can occur. Currently the top tread on the stairs is rotted.

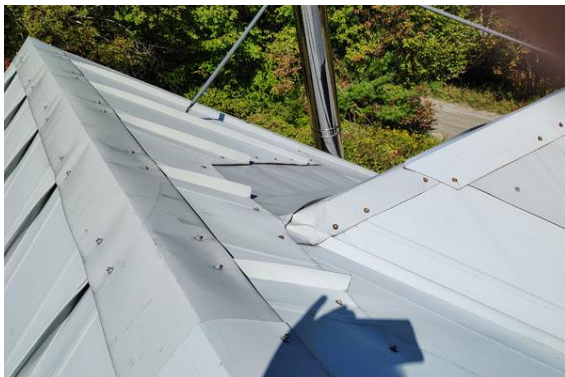
Improper installation

More pictures of improper material selection and installation.

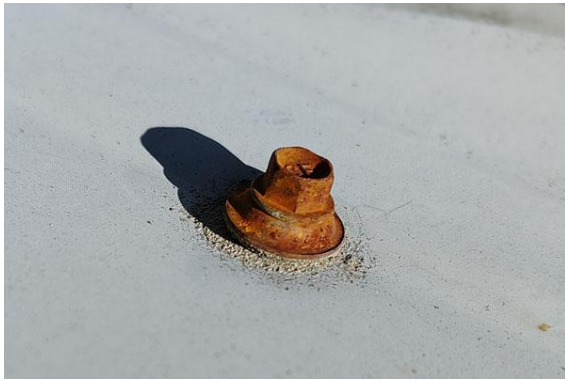
4.1 (3) Structure : Main House : Exterior : Roof : Roof Covering

I observed many of the fasteners on the roof appear to be at end-of-life. These fasteners are fitted with a neoprene gasket to prevent water intrusion through the screw penetration. The lifespan of these screws are typically between 10 and 20 years depending on environmental exposure. These should be replaced before water can find its way past the gasket material.

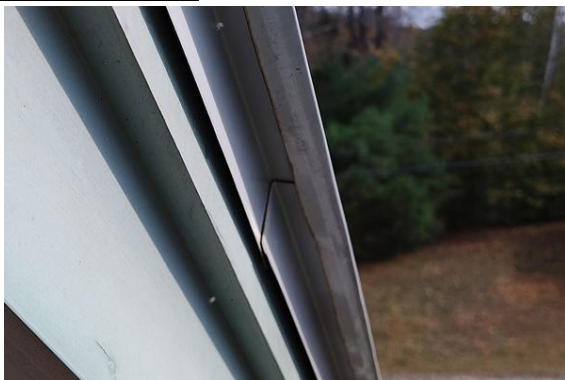
South side. Drip edge should be installed so that the upper section overlaps the lower section by at least 2". This was installed so that the lower section overlaps the upper section and overlapped by only ~1/4". This requirement is so that any water that may be clinging and running down the drip edge does not find its way to the roof decking. This same defect was observed on all rake edges of the main roof.

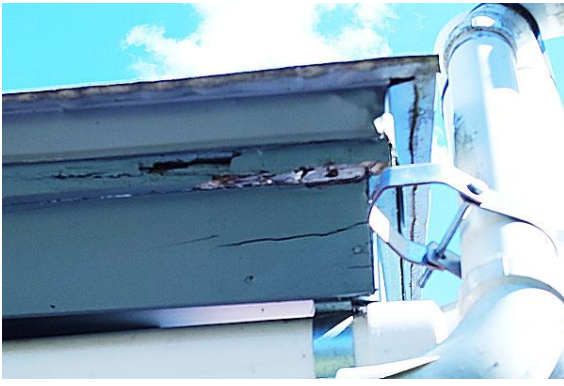
4.7 (1) Structure : Main House : Exterior : Roof : Facia

The fascia by the output of the radon system output is rotted. I discovered a missing roof fastener directly above this where water could enter the screw hole. This may have contributed to the defect.

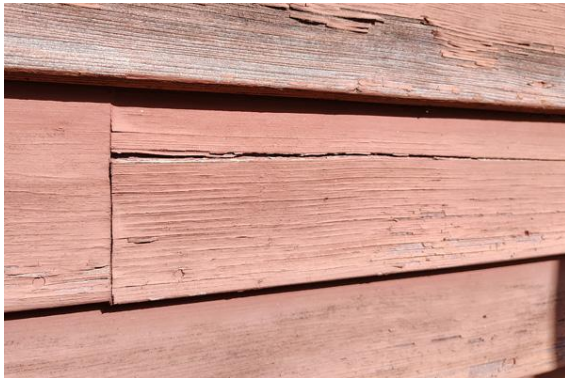
5.1 (2) Structure : Main House : Exterior : Wall Covering : Siding/Trim

There are several areas of the siding that are cracked or checked. This appears to be due to the lack of maintenance (paint). This image is from the right(south)side of the house.

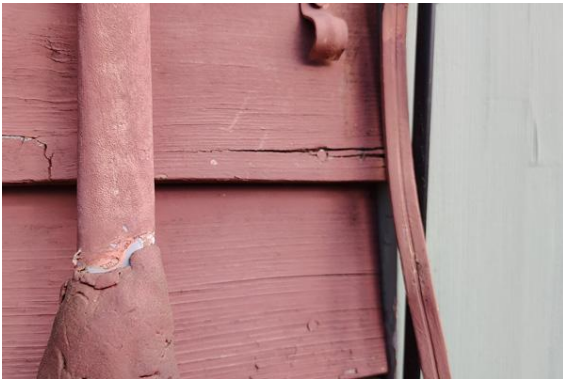
5.1 (3) Structure : Main House : Exterior : Wall Covering : Siding/Trim

Cracked/Checked siding

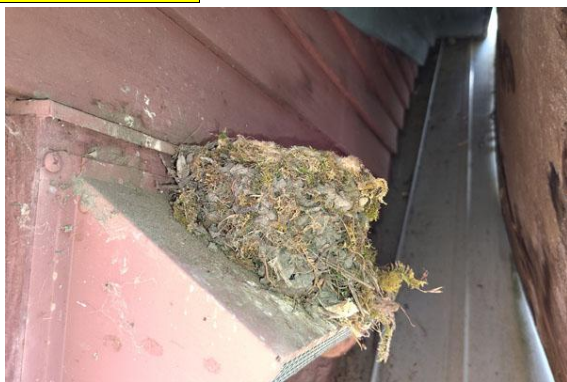
Birds will find isolated and protected areas to nest. Nests attract mites and can retain moisture leading to accelerated deterioration.

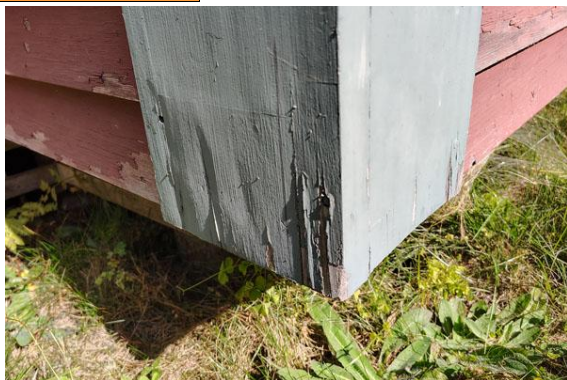
5.1 (12) Structure : Main House : Exterior : Wall Covering : Siding/Trim

Corner boards are weathered and should be evaluated. These may need to be replaced.

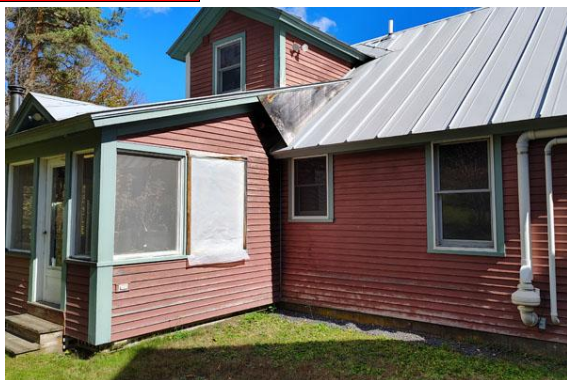
5.1 (13) Structure : Main House : Exterior : Wall Covering : Siding/Trim

Back of house shows a plywood installed presumably to mitigate further damage due to rain water coming off the dormer roof and splashing off of the lower roof and onto the siding. This would keep the area below the dormer roof wet and lead to advanced weathering.

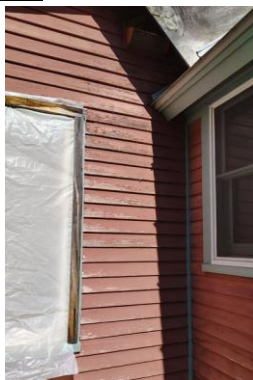
5.1 (14) Structure : Main House : Exterior : Wall Covering : Siding/Trim

Closer up of damage likely caused from the water splashing down from the roof above. As discussed in the above narrative.

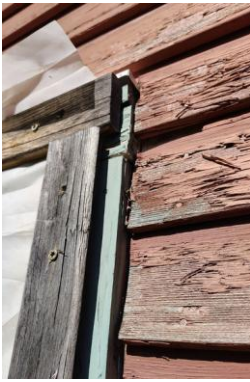
5.1 (15) Structure : Main House : Exterior : Wall Covering : Siding/Trim

Back Porch siding shows excessive weathering. Because of the lack of maintenance over the years, this should be evaluated by a siding professional

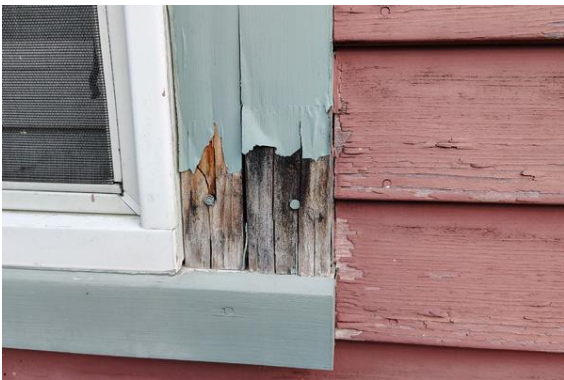
5.1 (17) Structure : Main House : Exterior : Wall Covering : Siding/Trim

Severely weathered trim board. There are many pieces of trim that should be repaired/replaced.

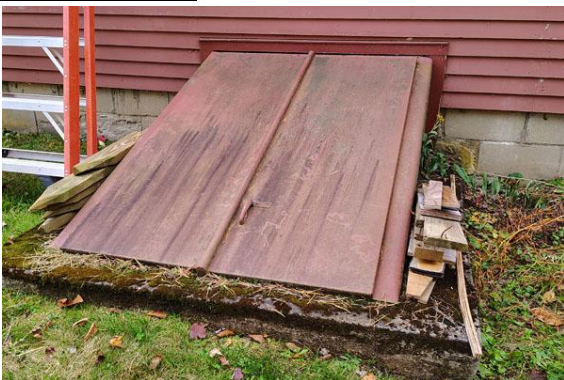
5.1 (18) Structure : Main House : Exterior : Wall Covering : Siding/Trim

Moss growth was observed around the bulkhead door. Moss will hold water longer creating an opportunity for rot. Moss should be taken care of at least on an annual basis. Moss retains moisture creating an opportunity for wood deterioration (rot) to occur.

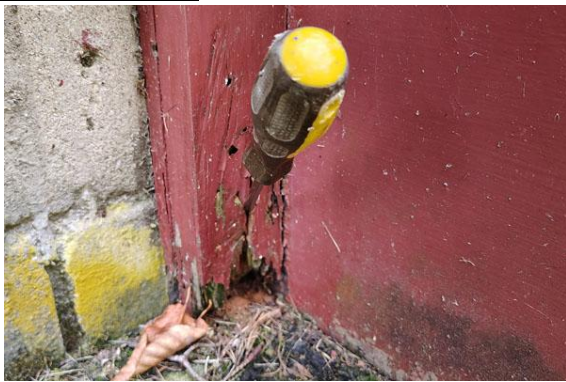
5.1 (19) Structure : Main House : Exterior : Wall Covering : Siding/Trim

Bulkhead trim rot

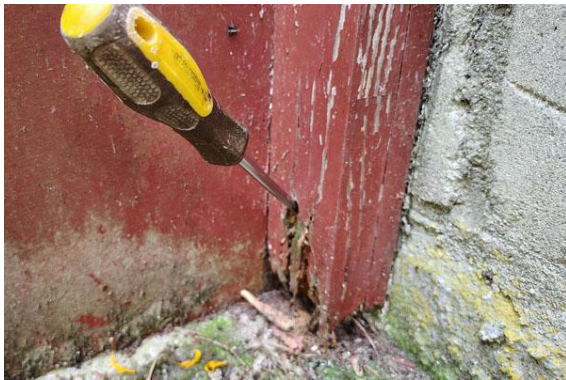
5.1 (20) Structure : Main House : Exterior : Wall Covering : Siding/Trim

The trim surrounding the bulkhead has rotted. This should be replaced and sealed as moisture could find it's way into the basement door area.

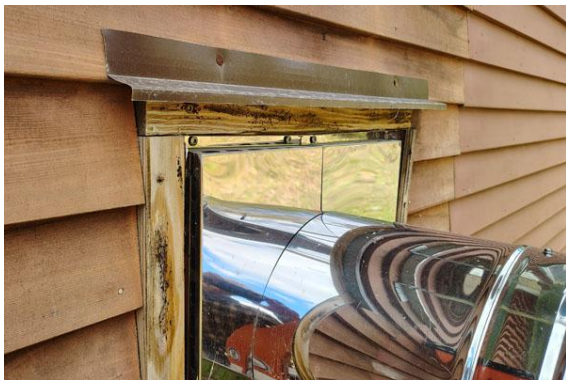
5.1 (21) Structure : Main House : Exterior : Wall Covering : Siding/Trim

Flashing was installed incorrectly. This could allow water to enter behind the opening for the chimney.

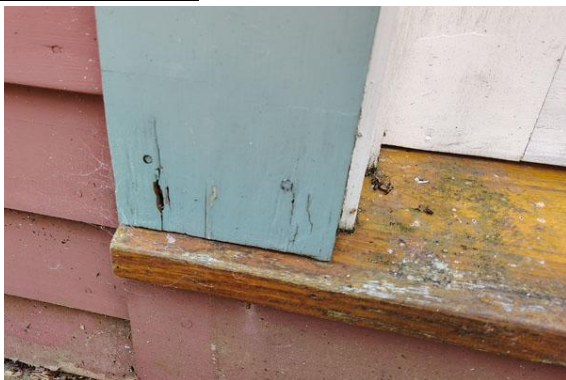
5.1 (22) Structure : Main House : Exterior : Wall Covering : Siding/Trim

Trim boards at the base of the deck door show signs of rot. These should be replaced to prevent further damage and moisture entry.

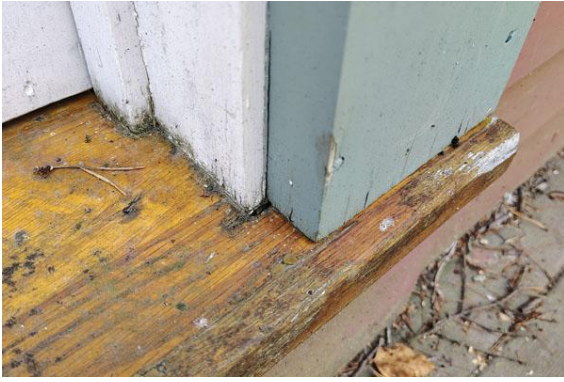
5.1 (23) Structure : Main House : Exterior : Wall Covering : Siding/Trim

Continuing the discussion of trim board replacement, these should be addressed.

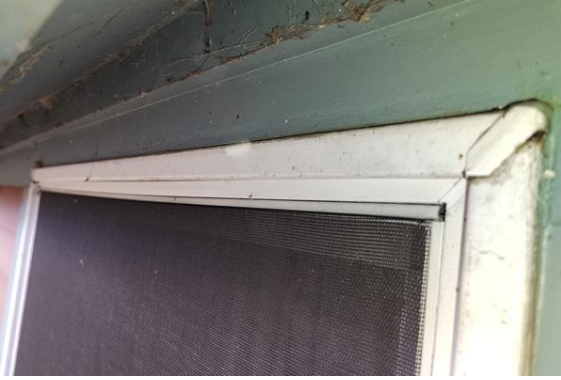
6.2 (1) Structure : Main House : Exterior : Windows/Doors : Flashing

Missing flashing was observed on both sides windows directly under overhang on both sides. Although this area is less prone to water intrusion, flashing is required avoid wind driven rain from getting behind the trim.

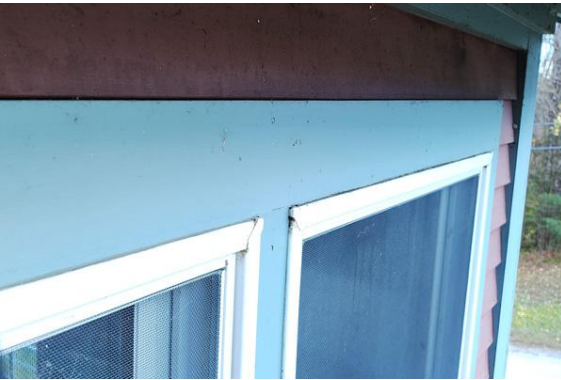
6.2 (2) Structure : Main House : Exterior : Windows/Doors : Flashing

More missing flashing

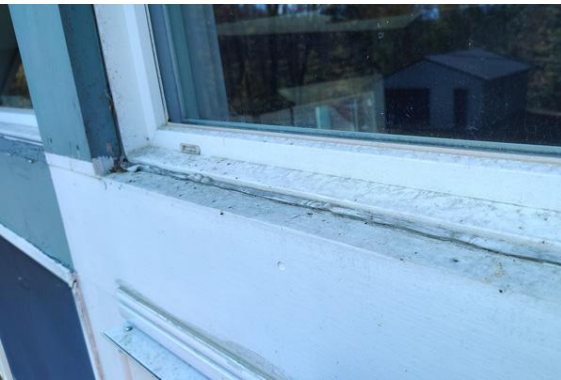
6.2 (3) Structure : Main House : Exterior : Windows/Doors : Flashing

Windows: missing flashing

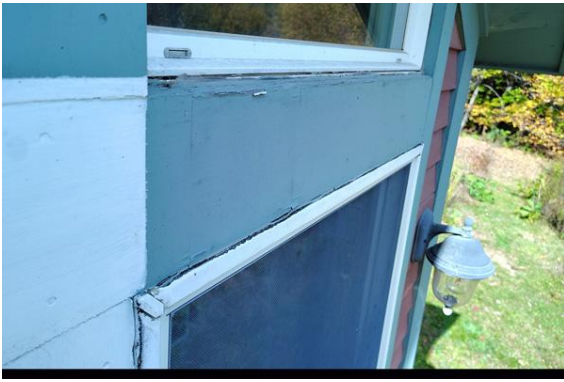
6.2 (4) Structure : Main House : Exterior : Windows/Doors : Flashing

Windows: missing flashing

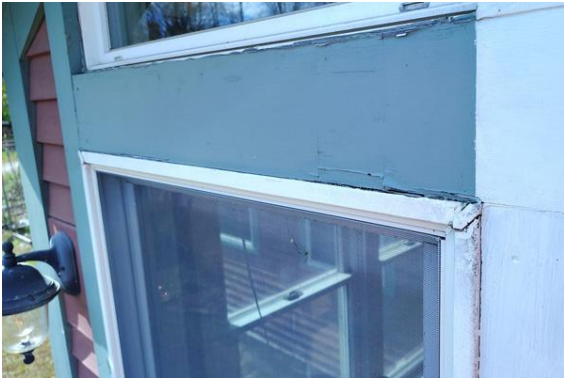
6.2 (5) Structure : Main House : Exterior : Windows/Doors : Flashing

Windows/Trim missing flashing

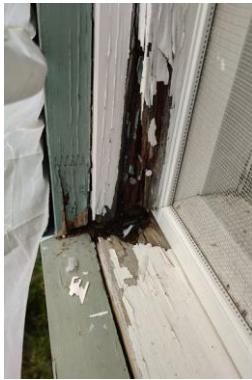
6.2 (6) Structure : Main House : Exterior : Windows/Doors : Flashing

Porch window rot

The window beneath the poly film has advance rot. This should be addressed sooner than later to prevent further damage to the wall system.

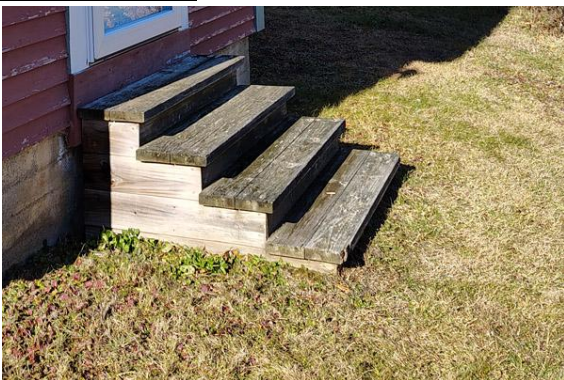
Front Entry Steps

Front entry steps are built with pressure treated lumber, They are old but appear to be functional. On visual inspection and walking on the treads, they appear to be solid. There should be a landing in front of the door, however to accommodate the outswing of the storm door.

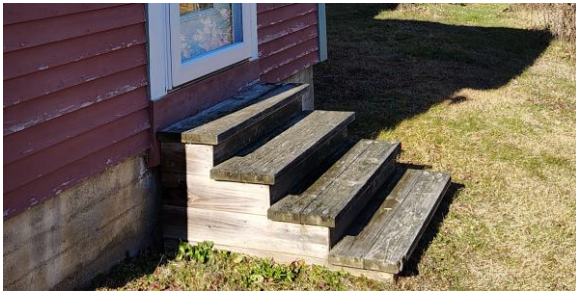
Rec ID 2583

Front entry steps are built with pressure treated lumber, They are old but appear to be functional. On visual inspection and walking on the treads, they appear to be solid. There should be a landing in front of the door, however to accommodate the outswing of the storm door.

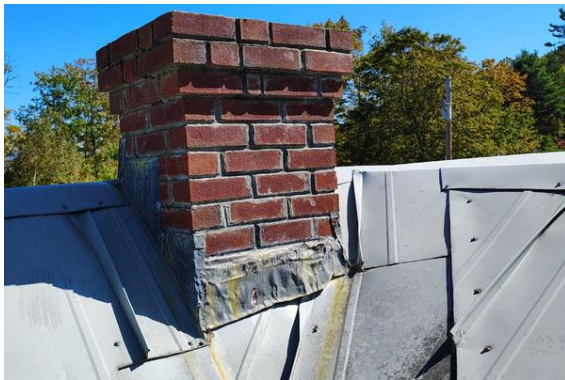
Rec ID 1202

Flashing and crown are deteriorating

There were a few areas on the chimney flashing that are cracked and allowing water to enter. This should either be sealed using silicone caulk (temporary) or the flashing should be redone (permanent). This should be evaluated/corrected by a chimney expert.

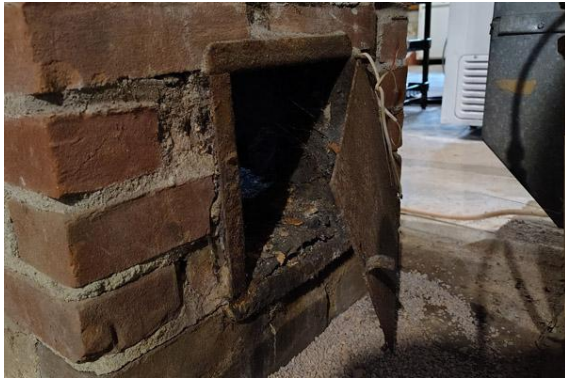
Rec ID 2049

Chimney access door needs replacement

The hinges on the chimney clean out door are broken. This should be replaced.

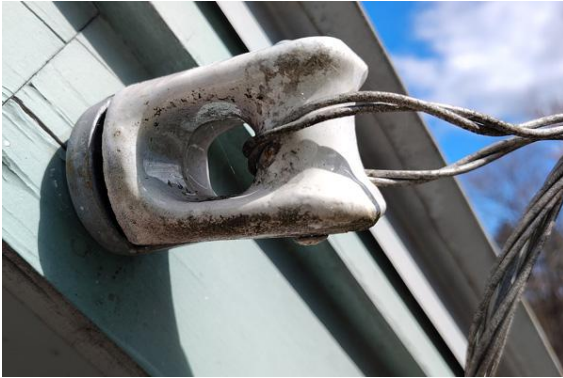
Rec ID 1219

Service Drop hanger at risk of failing

The service drop hanger may be pulling slightly away from building. This is a potential hazard if this fails as stress would be put on the service point (connection between the Service Drop and Service Entrance). I recommend an electrician evaluate and replace/resecure with a more appropriate hanger.

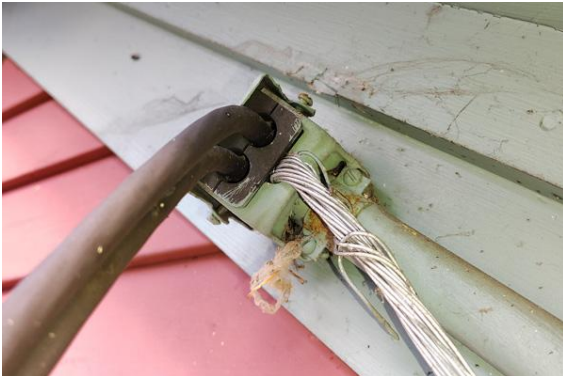
Rec ID 1227

The service entrance, where it runs through the weather head, shows a frayed neutral conductor. The reduction in cable size due to the frayed strands reduce the total ampacity of this conductor. This should be repaired by an electrician.

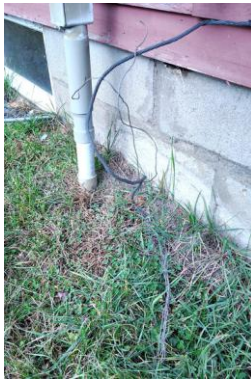
Ground wire frayed.

The ground wire is frayed where it enters the soil to connect to the ground rods. This conductor should be better protected, as lawn equipment can easily cause damage. Correction by a licensed electrician is recommended.

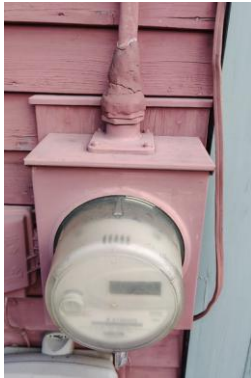
The clay weather seal is cracked and should be replaced

Clay is used to seal the service entrance at the meter box. Over time, this seal can dry out and deteriorate, which may allow water to enter the meter box and cause corrosion.

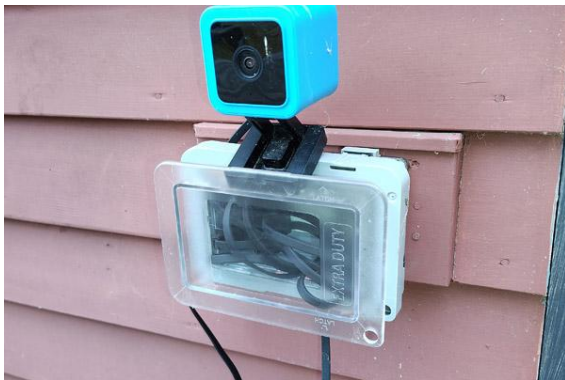
Receptacle blocked from testing

With the camera on the receptacle, I could not test the functionality receptacle.

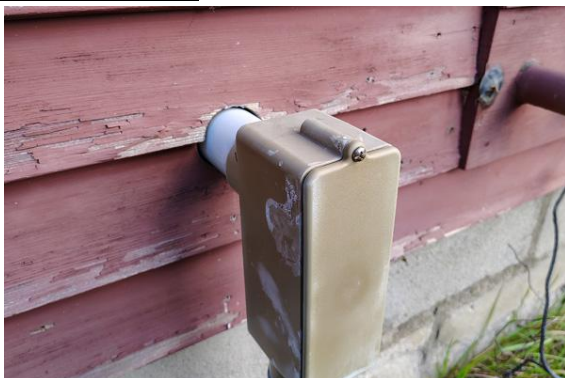
Missing sealant was observed at the outbuilding feeder penetratio

Sealant should be applied at all penetrations through the building envelope. This penetration supplies the feeder circuit to the garage. Proper sealing is important to prevent exterior air and moisture from entering the wall system.

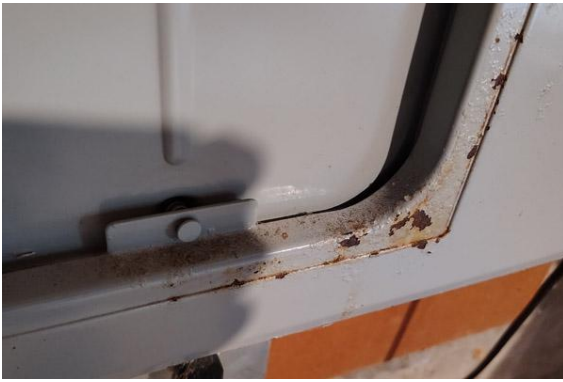
Rec ID 2056

Dead front corrosion

More corrosion on the dead front. I observed The inside of the panel shows no corrosion.

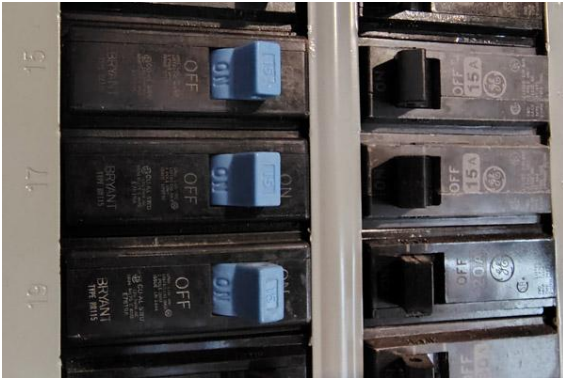
Rec ID 2060

I observed 4 different breaker brands being used in this panel. Generally, electric panels are only spec'd to use their own branded breakers. This is to ensure that full amperage can be achieved in the connection between the breaker to the buss bar. I observed 4 different breaker brands being used in this panel. This should be evaluated and/or corrected by an licensed electrician.

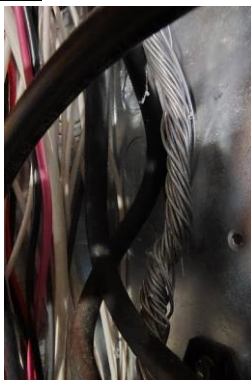
Rec ID 2057

I observed the neutral conductor inside the main panel is frayed. This could impact the total ampacity that this conductor can carry. I recommend a licensed electrician evaluate and correct.

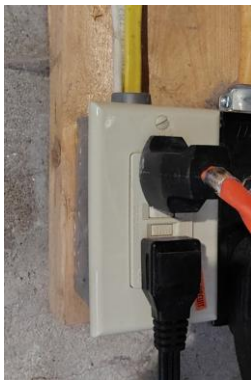
Rec ID 2052

20 amp circuit tapped with 14 AWG wire.

Typically 12 AWG wire is needed for a 20 amp circuit. When tapping into existing circuits, it's best practice to use the same gauge wire to ensure that the wire is protected by the correct amperage circuit breaker. This 14 AWG feeds a single load, a radon air pump that draws 60 watts.

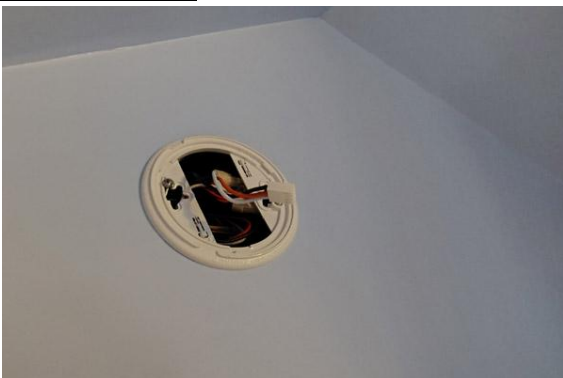
Rec ID 2097

Second Floor Bedroom - Missing Smoke/CO detector

I observed missing smoke detectors in the upstairs blue bedroom and wall in the common area outside of the bedrooms. Smoke/CO alarms are necessary to alert to a potential life threatening event.

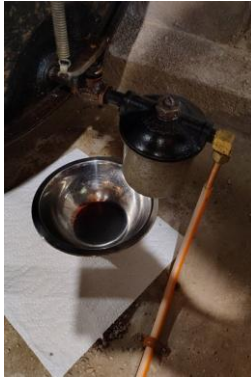
Rec ID 2070

The heating equipment and water heater is fueled with fuel oil. This is an older tank as is evidenced from the rust. The tank itself is not leaking however the fittings before the fuel filter exhibits a slow drip.

I observed a known oil drip coming from the connections off the fuel oil tank. This should be corrected by heating or plumbing contractor.

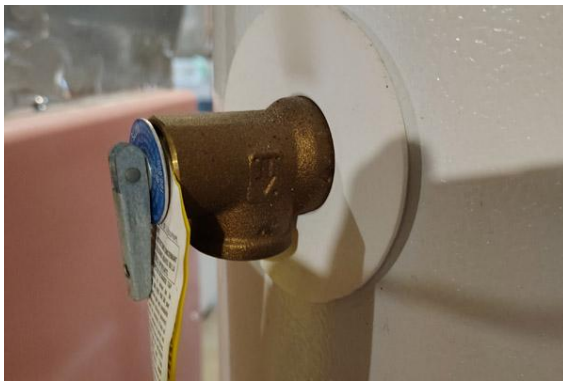
Rec ID 2080

Missing discharge pipe on water heater TPR valve.

The TPR (Temperature & Pressure Relief) valve is missing the discharge pipe. This pipe is necessary to avoid spraying hot water in the event of the release of water. This is an easy fix but a safety defect.

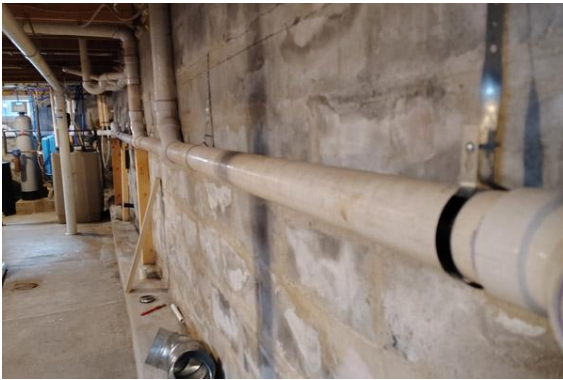
Rec ID 2079

The drain that wraps around the back side of the basement is supported with sticks of 2x4s. This appears to be temporary and should be supported with a permanent solution. The main drain does appear to be functioning properly as no leaks were observed.

The main drain appears to have temporary support along the length of the pipe. It should be secured with a more permanent solution.

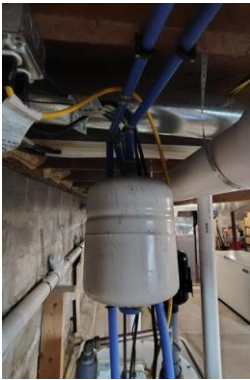
Rec ID 2074

Expansion tank not supported

There is a small expansion tank above the radon bubbler. This only hanging on the pex plumbing. This should be supported on its own.

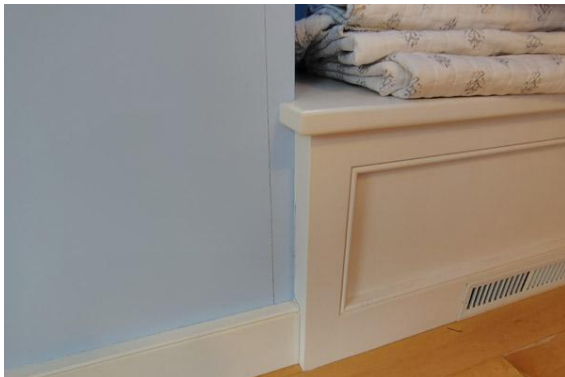
Rec ID 2093

Second Floor Bedroom - Crack in drywall cornerbead

I observed a crack in the drywall next to the seat under the dormer area. No other evidence but keep an eye on it to verify that the crack doesn't widen.

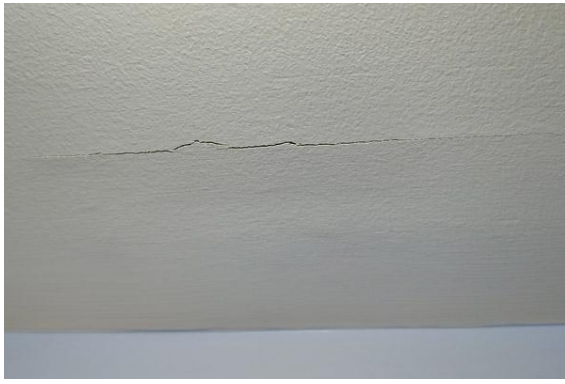
Rec ID 2122

Drywall crack in ceiling of first floor blue bedroom

I observed a small crack in the ceiling drywall. Sometimes a crack is only a crack and not evidence of something bigger. Recommendation is to monitor.

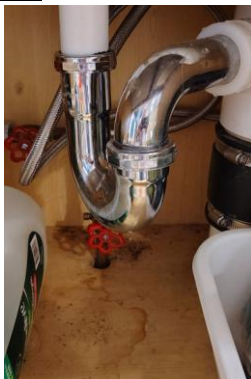
Rec ID 2123

Minor Defect

Evidence of leaking drain.

The kitchen drain shows evidence that it has leaked. While not currently wet after running water, it should be monitored to verify there is no active leak.

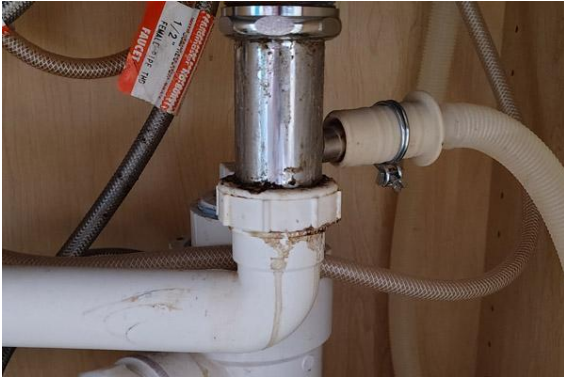
Rec ID 2126

17.1 (3) Interior Elements : Main House : Kitchen : Plumbing

Minor Defect

Possible leak in drain under smaller sink

I observed a potential leak in the drain of the smaller of the two bay kitchen sink. It was not actively wet (may have already been repaired) but keep an eye on to verify that the fittings no longer leak.

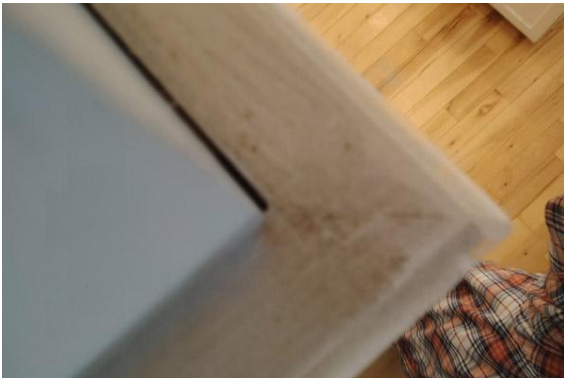
Rec ID 2124

17.5 (1) Interior Elements : Main House : Kitchen : Cabinets/Countertop

Minor Defect

While this is a minor defect, painting the top side of molding allows for easier cleaning and protects the wood from both cleaning products and moisture from cooking and day-to-day activities.

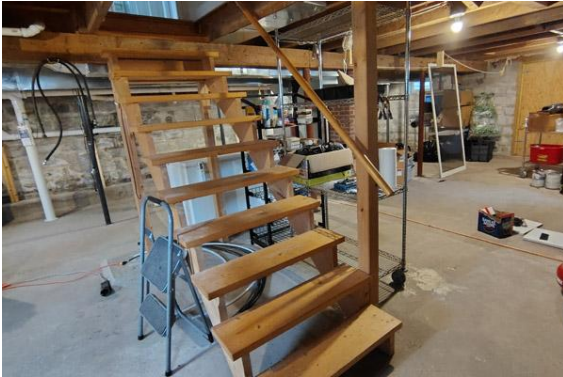
Rec ID 2091

19.2 (1) Interior Elements : Main House : Staircase : Basement

Minor Defect

I observed missing balusters & missing risers. This is a safety concern as a small child could fall through the open areas of the staircase.

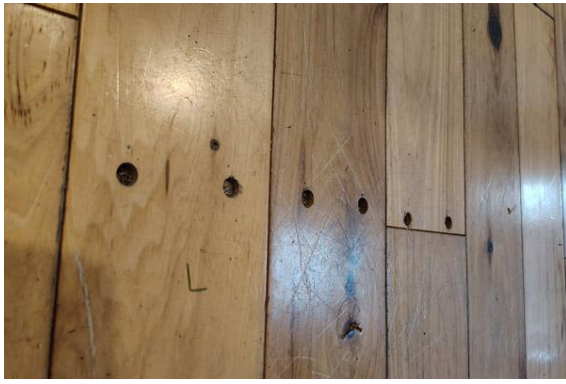
Rec ID 2131

19.3 (1) Interior Elements : Main House : Common Areas : Walls/Ceiling/Floor

Minor Defect

I observed that the floor is slightly "wavy" and a few portions were resecured. This might be indicative of wood expansion from humidity and moisture. The wood species on the first floor's floor is hickory. Hickory is known to have large expansion characteristics with seasonal changes.

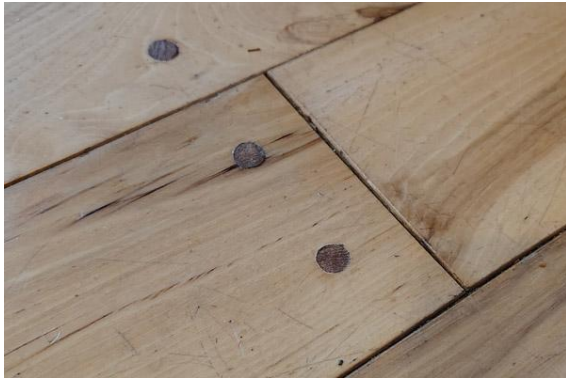
Rec ID 2132

19.3 (2) Interior Elements : Main House : Common Areas : Walls/Ceiling/Floor

Floor resecured.

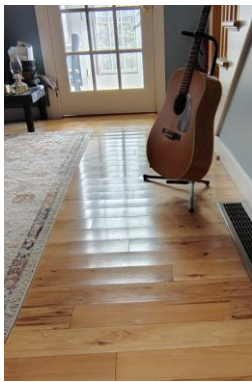
Rec ID 2128

19.3 (3) Interior Elements : Main House : Common Areas : Walls/Ceiling/Floor

Minor Defect

The hardwood floor exhibits cupping. This may have been installation defect or could indicate excessive moisture.

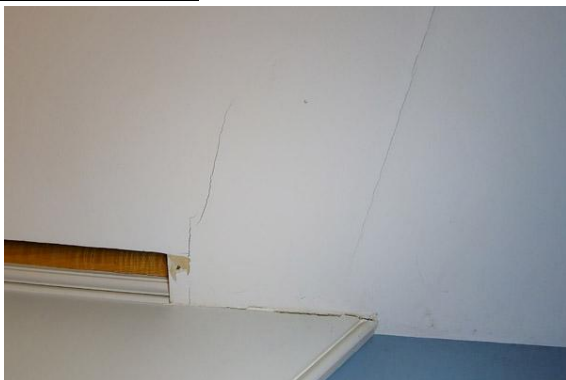
Rec ID 2101

19.3 (4) Interior Elements : Main House : Common Areas : Walls/Ceiling/Floor

Minor Defect

Cracked Drywall - First Floor Ceiling

I observed some drywall cracks that occurred next to the stairs and on the other side of the kitchen along the same line (middle of house).

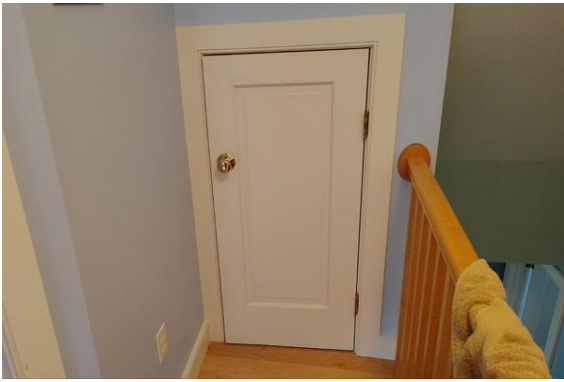
Rec ID 2102

19.4 (1) Interior Elements : Main House : Common Areas : Windows/Doors

Minor Defect

The closet door has a tight fit requiring slight force to close. There was no racking observed indicating that this most likely was an install defect.
